Charlestown Civic Center Assessment

November 12, 2020

HWC
ENGINEERING

EOP Architects

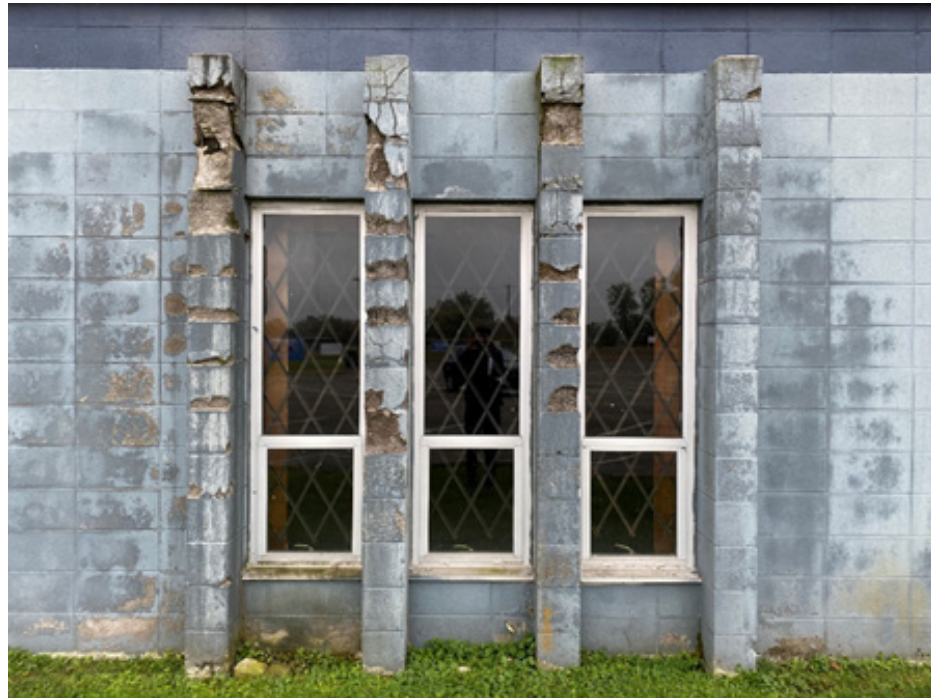
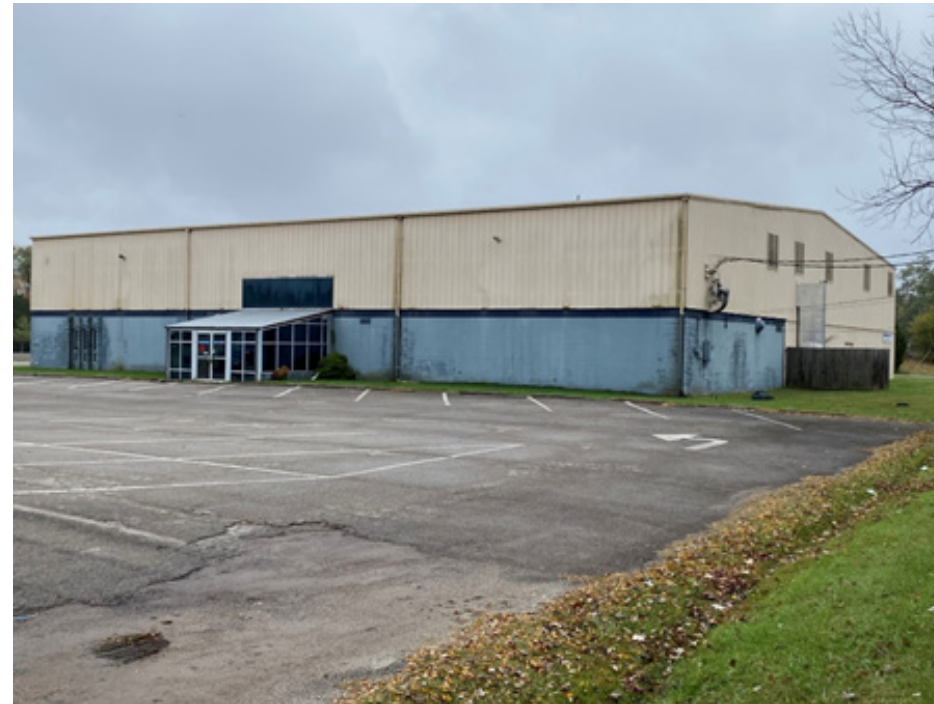
Front Façade

The Front (northwest) façade consists of Vertical steel metal panels with exposed fasteners sitting above painted single width CMU with aluminum punched window opening. A storefront entry vestibule was a latter addition.

Single width CMU is filled with Styrofoam beads for insulation. It should be noted that this is not a recognized form of insulation by the Energy Code. CMU is in a heavy state of disrepair as wall face in many locations is disintegrating exposing interior core of the block, including base of wall at ground level. This is most likely due to water infiltration and freeze thaw action. Water infiltration is most likely from a number of factors including sloping grade towards building, roof leaks, damaged gutter and downspouts, surface absorption and vapor drive. Paint finish was chalking and spalling from CMU face.

The exterior finish is steel vertical formed metal panel with exposed fasteners, directly attached to structural steel horizontal purlins. Wall insulation consists of 2" of fiberglass with vinyl scrim, which also serves as the interior finish. Insulation does not meet current energy codes. Finish was chalking and rust corrosion through the panel were evident at multiple locations.

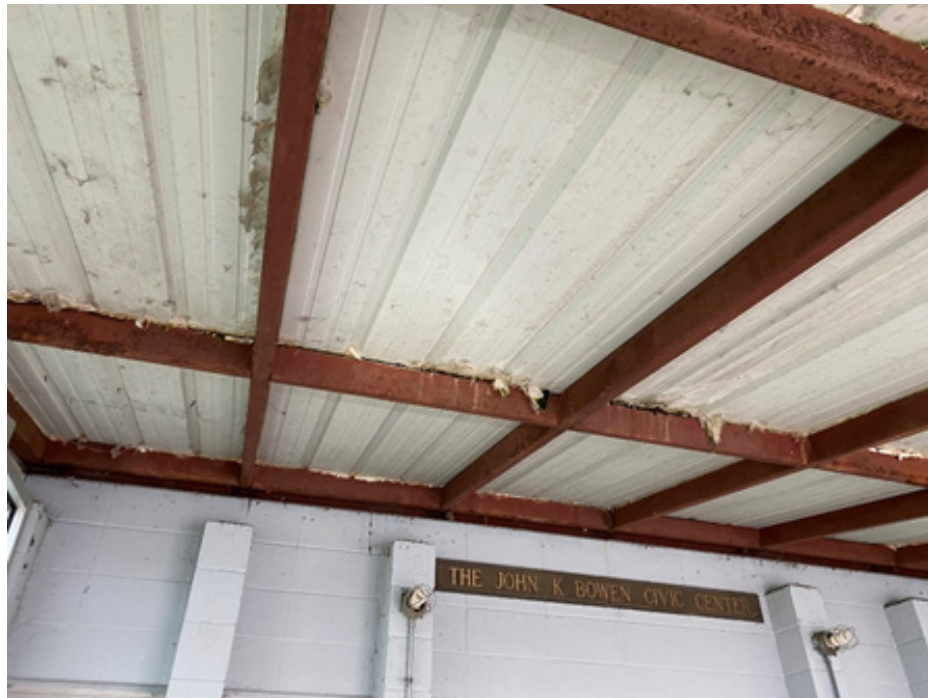
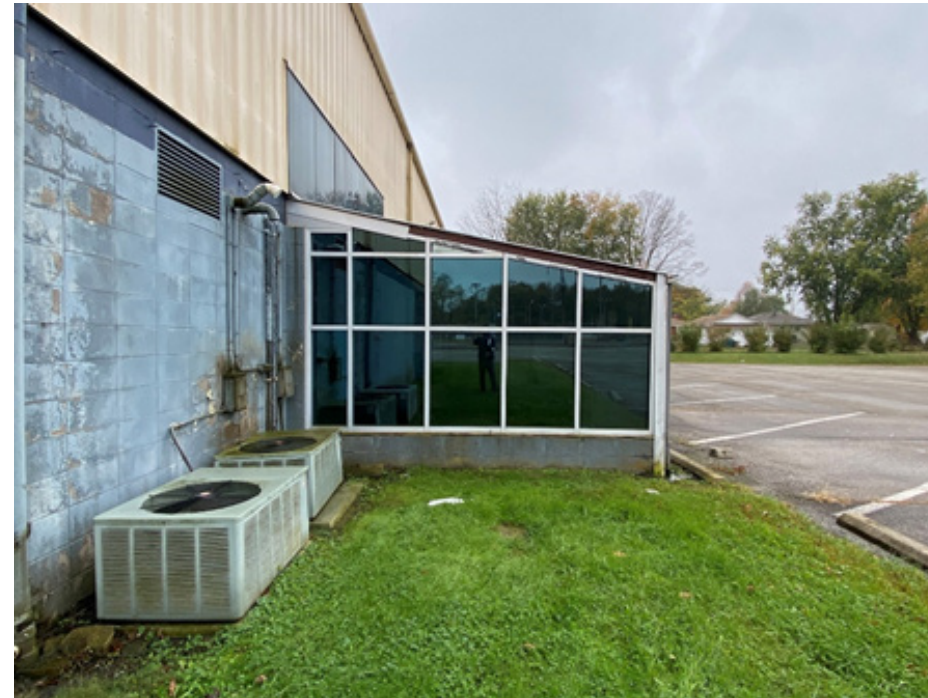
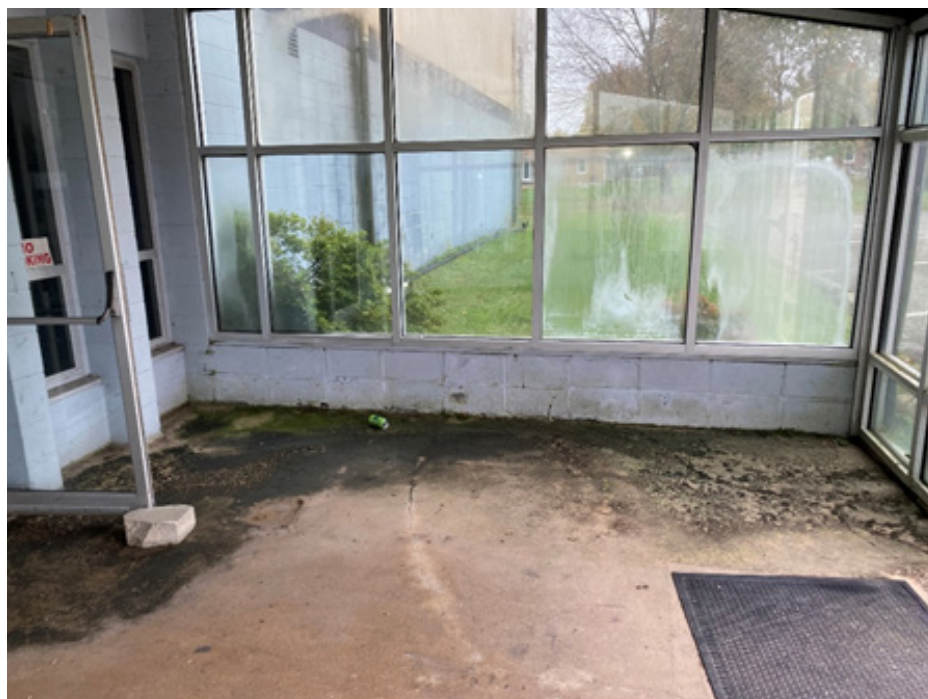
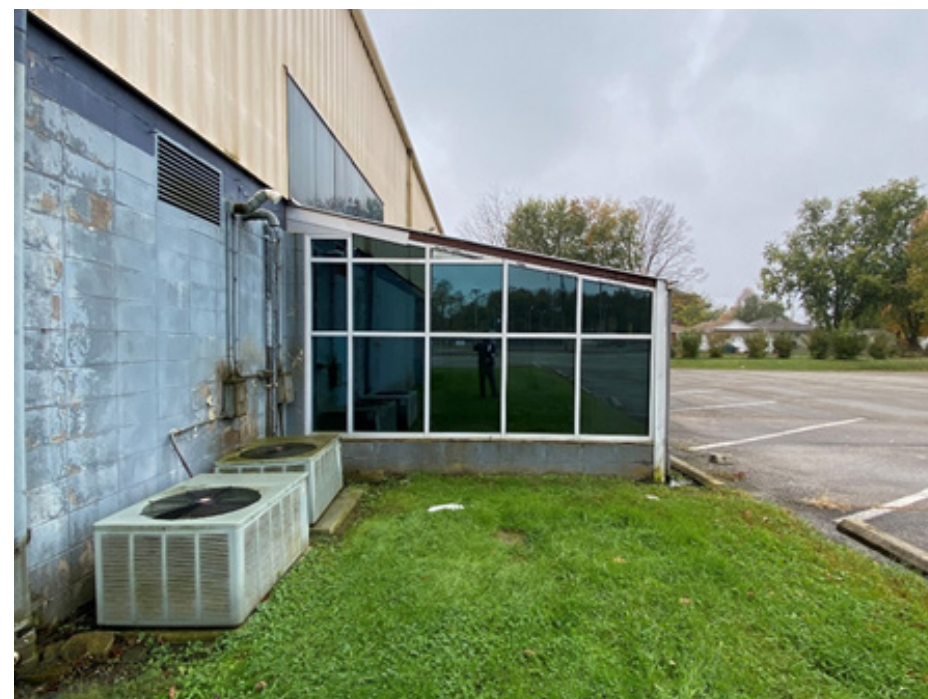
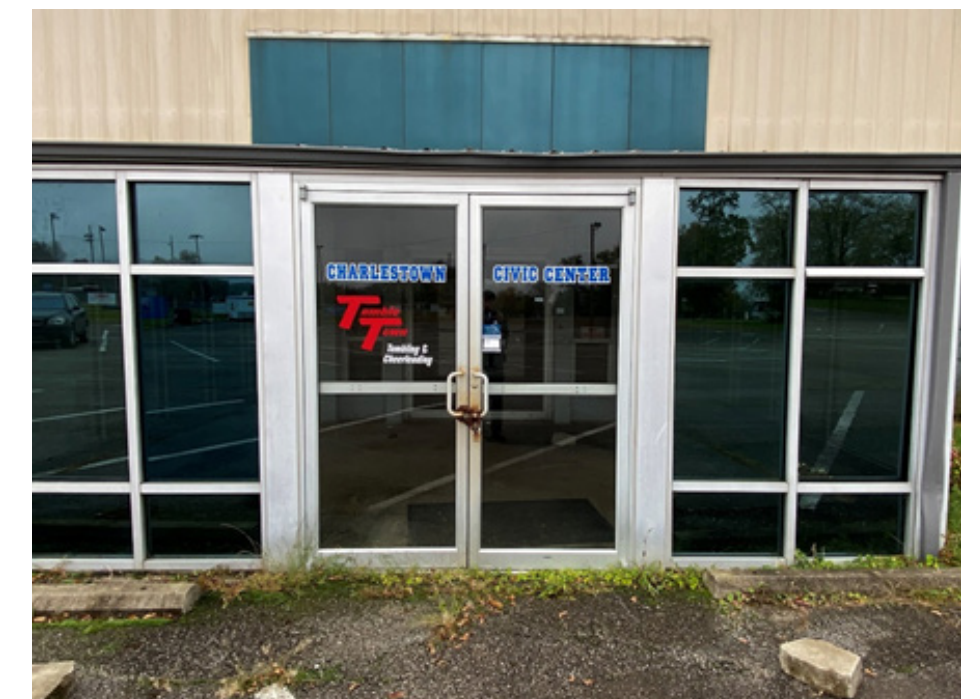
Entrance Vestibule Addition

The Entry Vestibule, a latter addition to the building is of poor construction. Framing consists of a steel tube frame, sloped to the front with a continuous gutter. Sections of steel framing were visible on the exterior of the building with no protection. This was then in-filled with storefront sitting atop a two-course unreinforced CMU stem wall. CMU wall has visible open cells to the exterior partially capped with exposed dimensional wood material with no sill flashing. Parking lot slopes to front entry draining water into the building. Vestibule slab was cracked and settled and had signs of ponding water. Front entry must be chained in order to secure the building. Many of seals have failed on the glazing units causing them to fog up. Space was not conditioned. Space was only lit by (2) wall mounted jelly jars. Interior roof insulation is missing exposing underside of roof deck to view. Roof gutter was missing end cap allowing water to drain out the end.

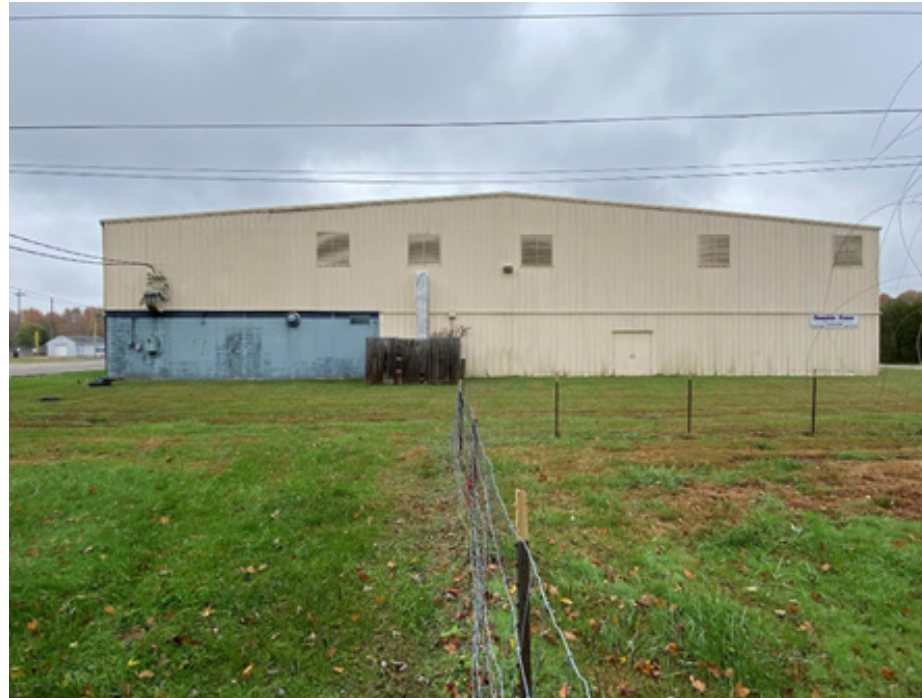
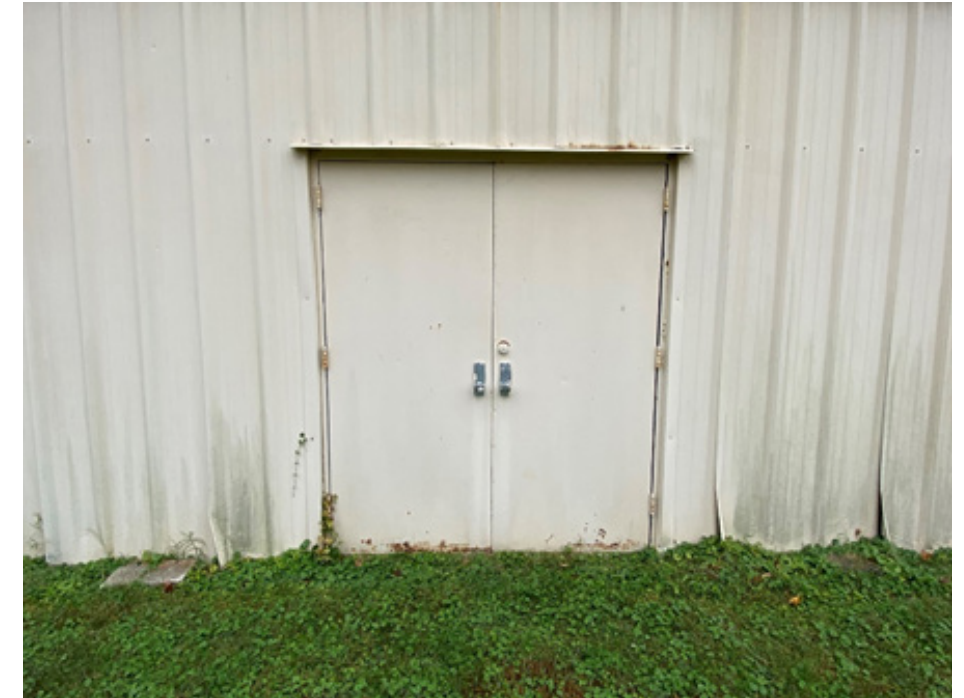
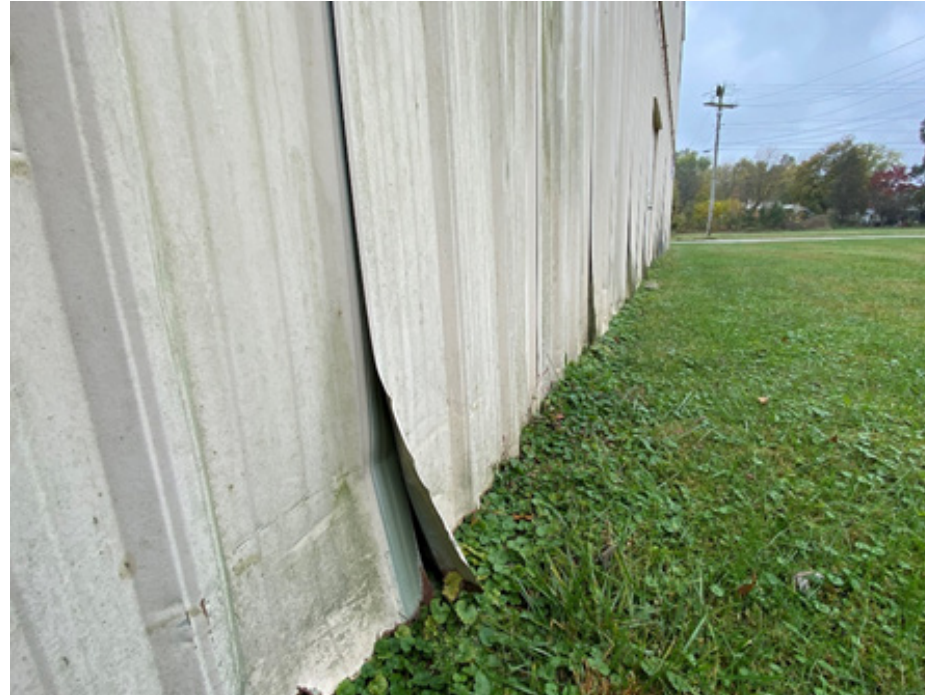
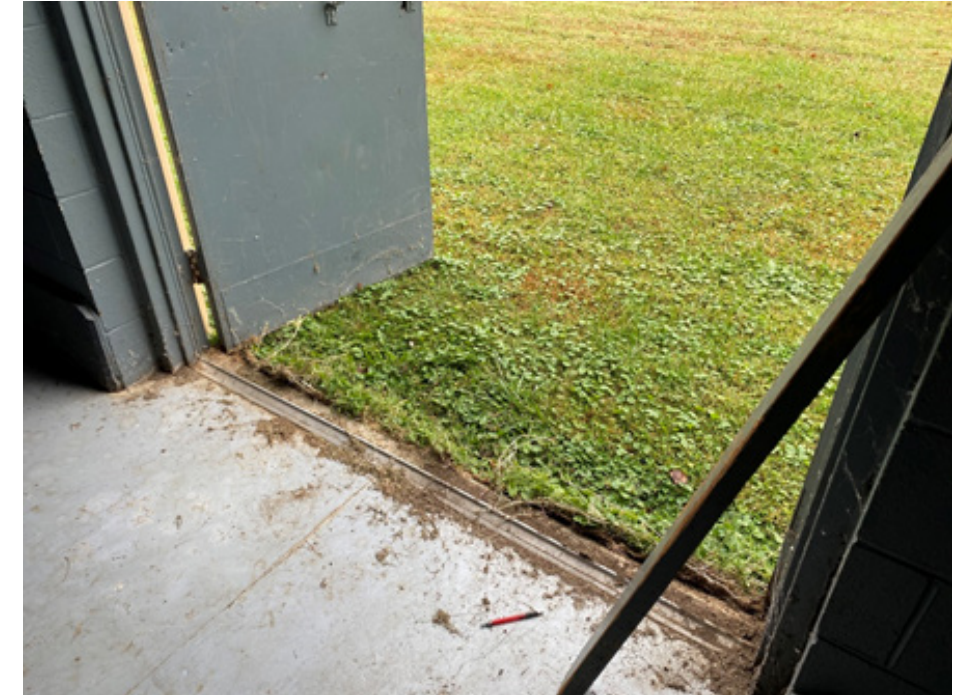
Side Façade Facing Neighborhood

The Side (southwest) elevation faces the rear yard of one-story single-family homes. Façade has same materials as front façade with similar issues. Grading is also an issue on this side, which is slightly above interior finished floor and bottom of metal wall panels. Surrounding grade was also not draining properly with ponding water observed against the building. This has caused the metal panel bottom sill flashing to deteriorate and exposed fasteners to completely fail. Bottom of panels are curling due to no positive attachment. Panels could be moved several inches with minimal pressure applied. A pair of hollow metal doors were exhibiting signs rust and had to be secured via chain. A series of five (5) through wall louvers with hinged closures panels on the inside were most likely used for cross ventilation on temperate days. No mechanical fans were observed on the interior and closure panels are hard to access due to height. Most of the building utility services are located on this side of the building. Electrical is fed overhead from three (3) pole mounted transformers. Telecommunications also enter the building from overhead, however underground telecommunications service appears to be located in close proximity to the building. Three (3) underground water meters pits are also located on this side of the building. A single on grade air handling unit (AHU) is located within a fenced-in enclosure. A single wall pack mounted light has a broken lens cover. An easement between two houses also occurs on this side of the building leading to Monroe Street.

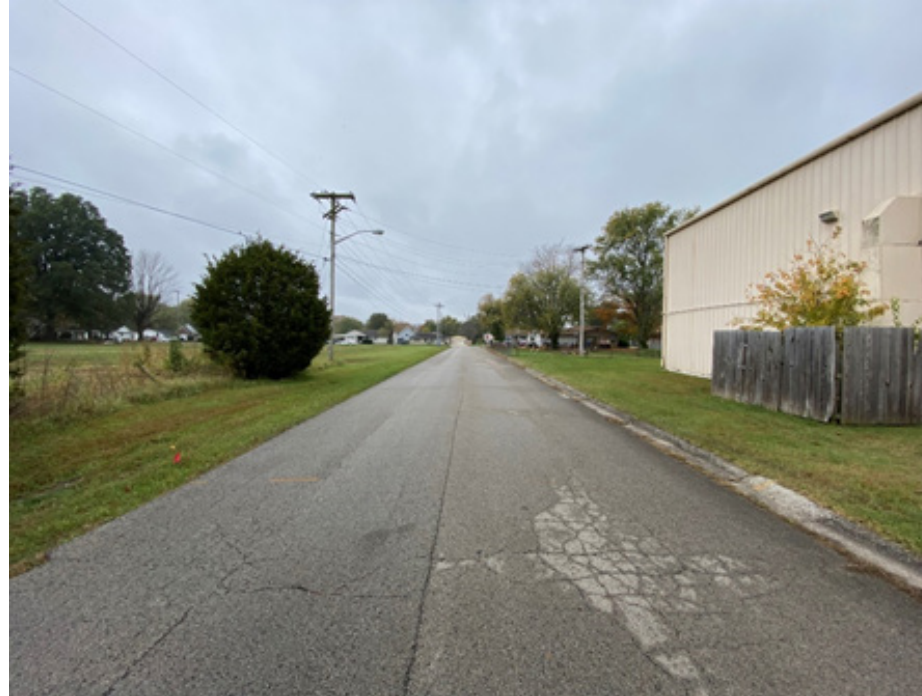
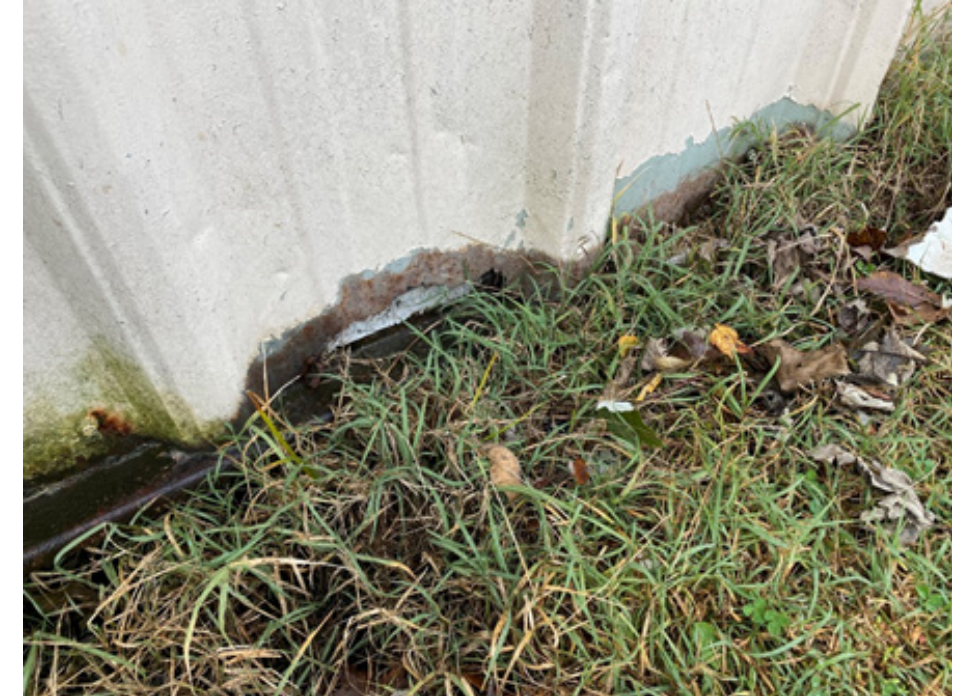
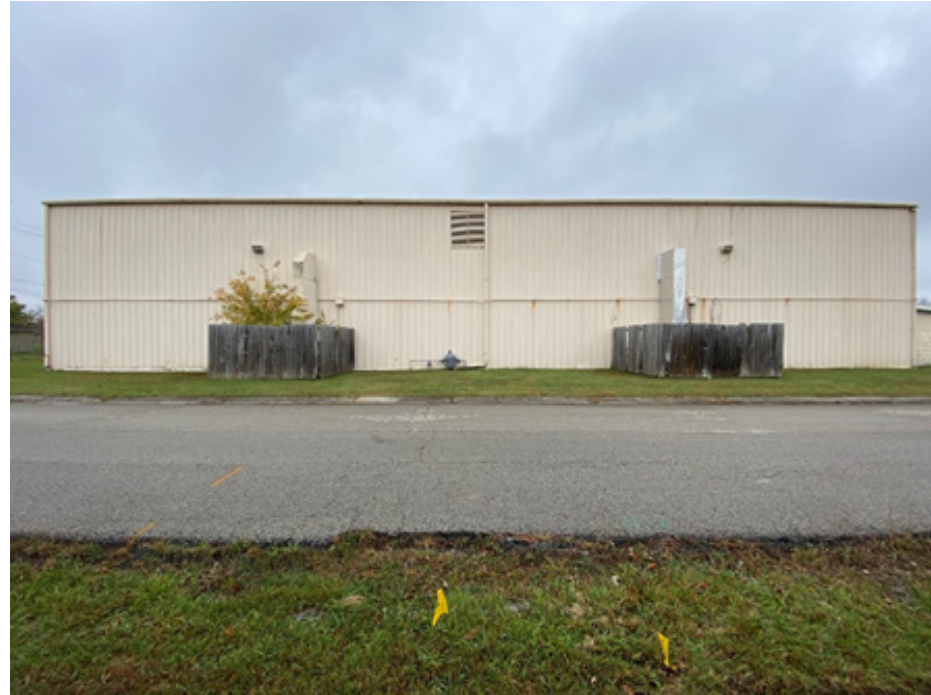
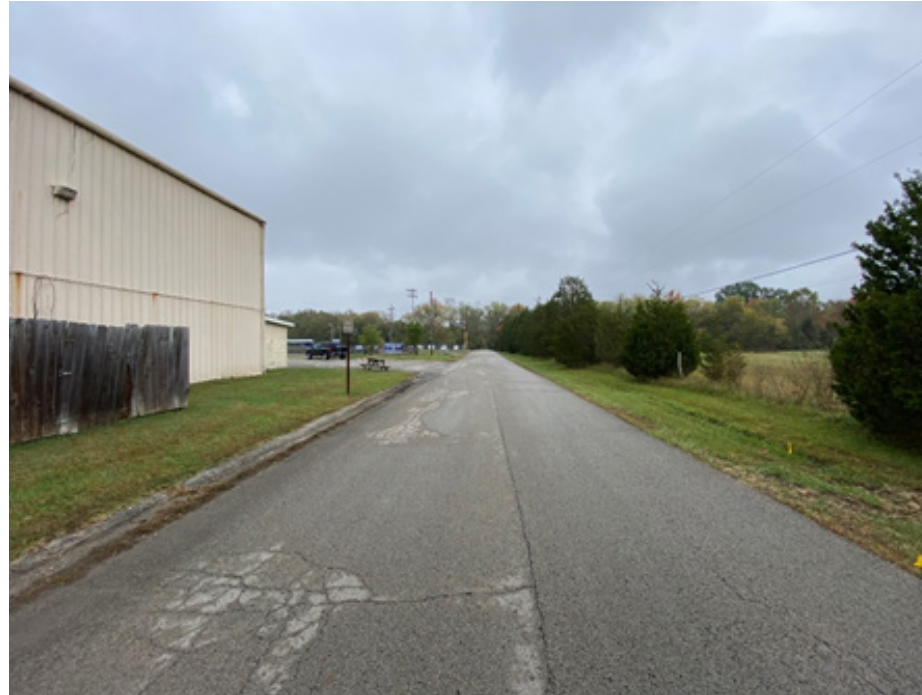
Rear Facade

The rear (southeast) elevation faces Steve Hamilton Drive . Façade is made up entirely of vertical steel metal panel with exposed fasteners. Panels are exhibiting the same issues of deterioration as the rest of the building. A single through wall louver is located on the center of the façade. Gas service to the building is also located on this side. (2) (AHU) units are located at grade surrounded by wooden fences. Two light wall packs have broken lenses.

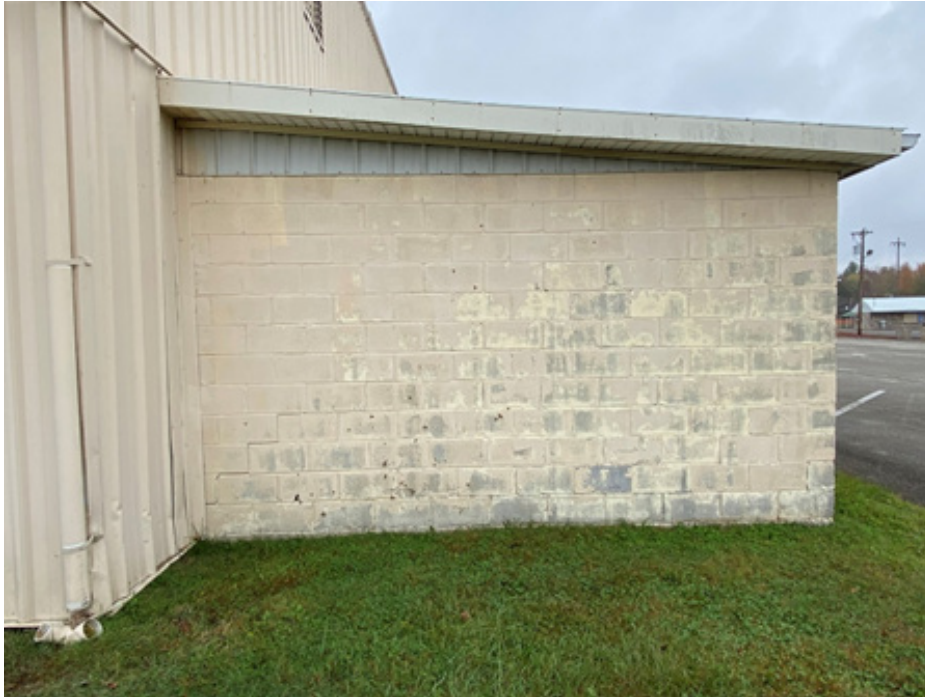
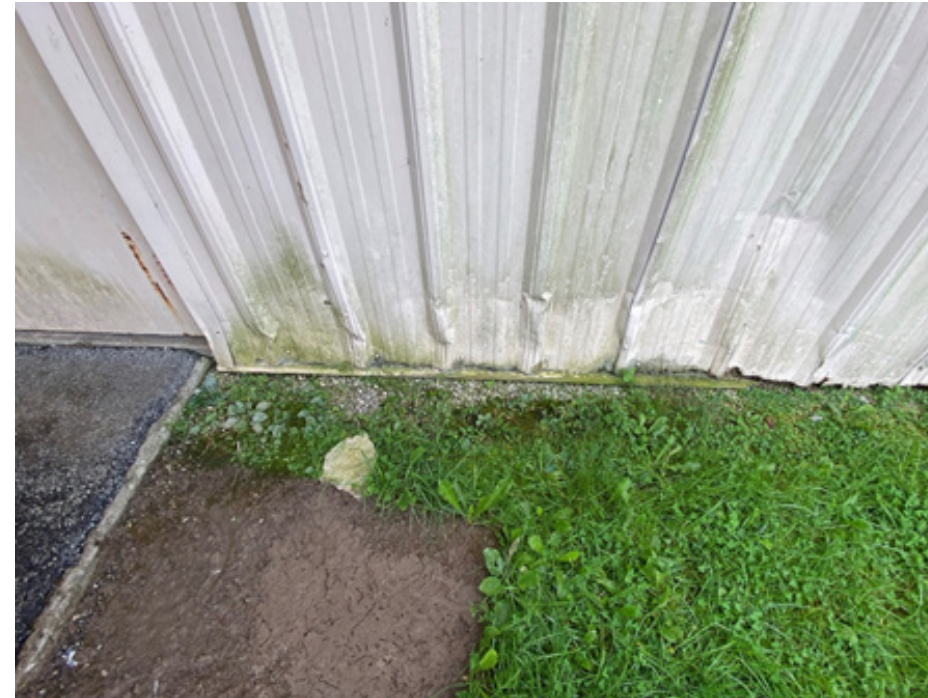
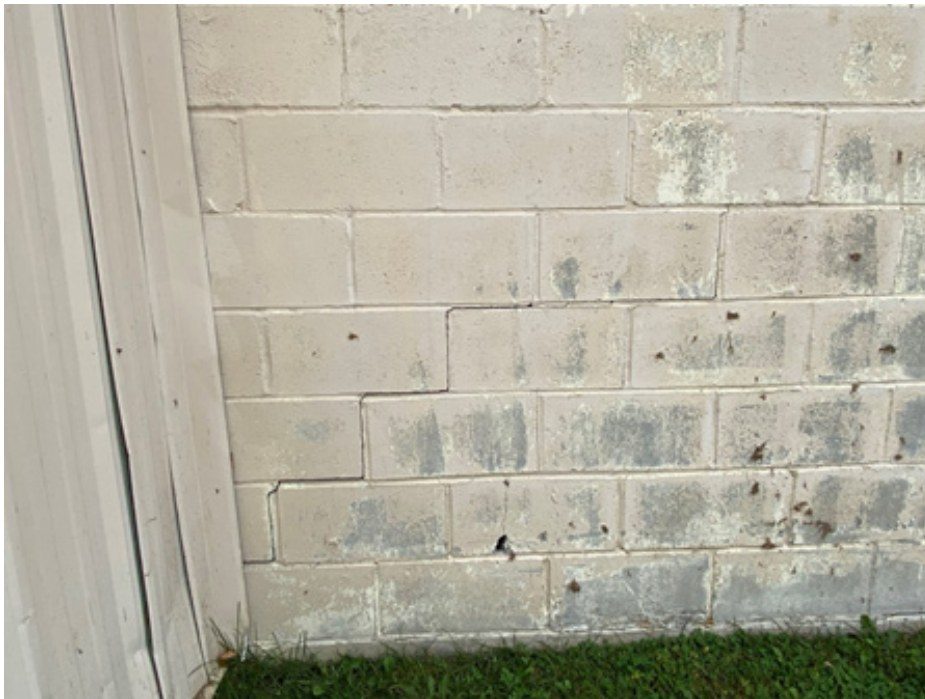
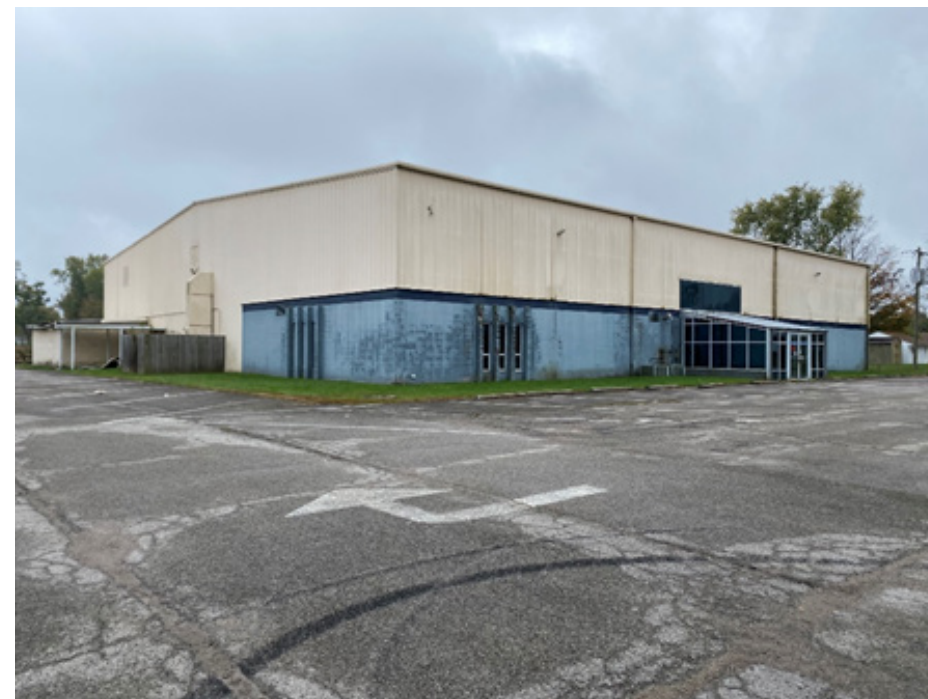
Side Façade Facing Parking lot

The side (northeast) elevation has same materials as front façade with similar issues. Two (2) through wall louvers are located on this elevation. One (1) (AHU) is located at grade surrounded by a wooden fence. A pair of hollow metal doors are secured with a chain. Side gym entry Doors are covered by an aluminum canopy leading to the parking lot. Canopy appears as if it had a large impact as roof panel is dented and cracked. A small one-story load bearing single width CMU addition has visible cracking and holes. CMU does not appear to have grouting or insulation. Roof structure is a single slope on wood rafters and decking. Note, combustible construction is not allowed in Type IIB construction. Fascia has failed along the leading edge of the roof.

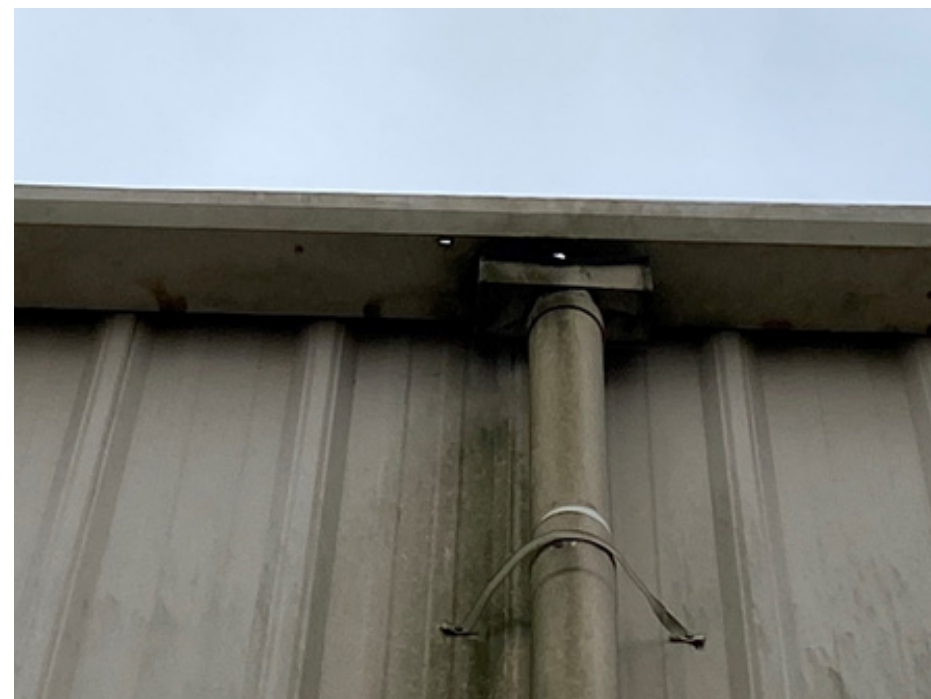
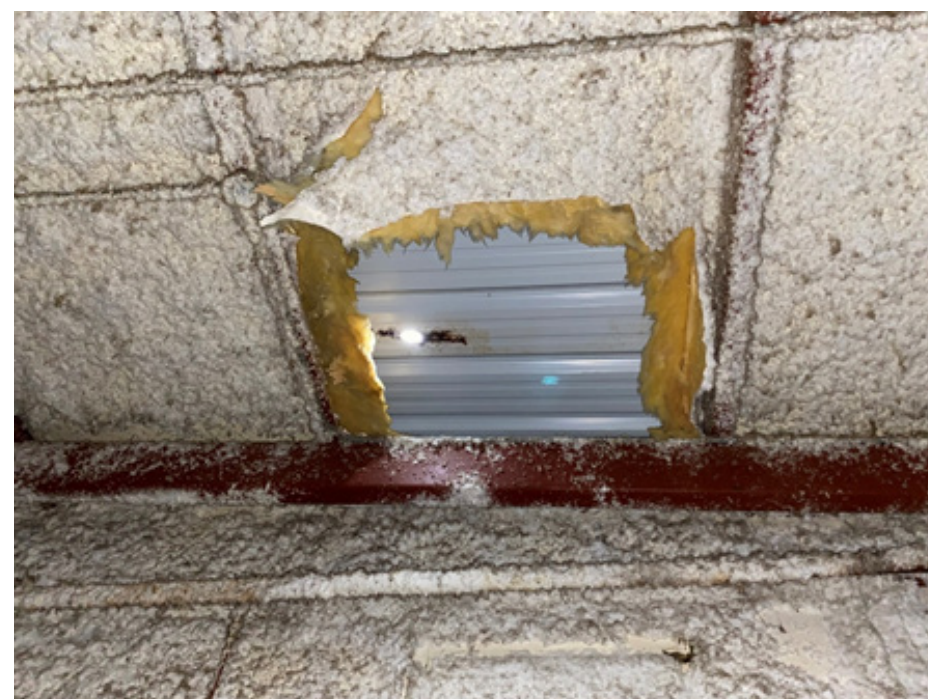
Roofing

Roof appears to be a 3/12 gabled roof pitching to two sides. The roof is painted steel roof panels with exposed fasteners. A visual inspection was not able to occur at the time of the assessment due to lack of access and safety concerns due to the current condition of the roof. However, from aerial photography, city commentary and interior conditions, it can be reasonable inferred that the roof is failing and beyond its serviceable life. From satellite photos it appears that multiple attempts have been made to repair the roof over the years. Severe rusting of panels is also evident. Daylight was visible through the roof from one interior location and visible water damage was evident at multiple locations.

The main roof drains to continuous gutters running the entire length along the bottom edge of the roof. The gutter appears to be properly sized to accommodate the size of the roof. Gutters had visible holes and rust deterioration and were visibly leaking at the time of the inspection. Downspouts are dented in many locations and leaking at joints. Boot connections at the bottom of downspouts are missing or heavily damaged, causing water to collect at the base of the building. This has helped contribute to visible failure of CMU and metal panels along the base perimeter of the building, allowing for water migration into the building.

The front entry addition has a single sloped metal panel roof with exposed fasteners. Roof insulation has also been removed from underside of decking most likely due to water damage. Gutter is missing end cap allowing water to free flow from the end.

Side addition has single sloped metal panel roof with exposed fasteners. It appears that the roof has a less than 3/12 recommended minimum roof slope. Deck is supported by wood roof rafters and decking. Front fascia and gutter along the leading edge has failed and is visible hanging exposing the ends of the wood roof rafters and failed wood decking.

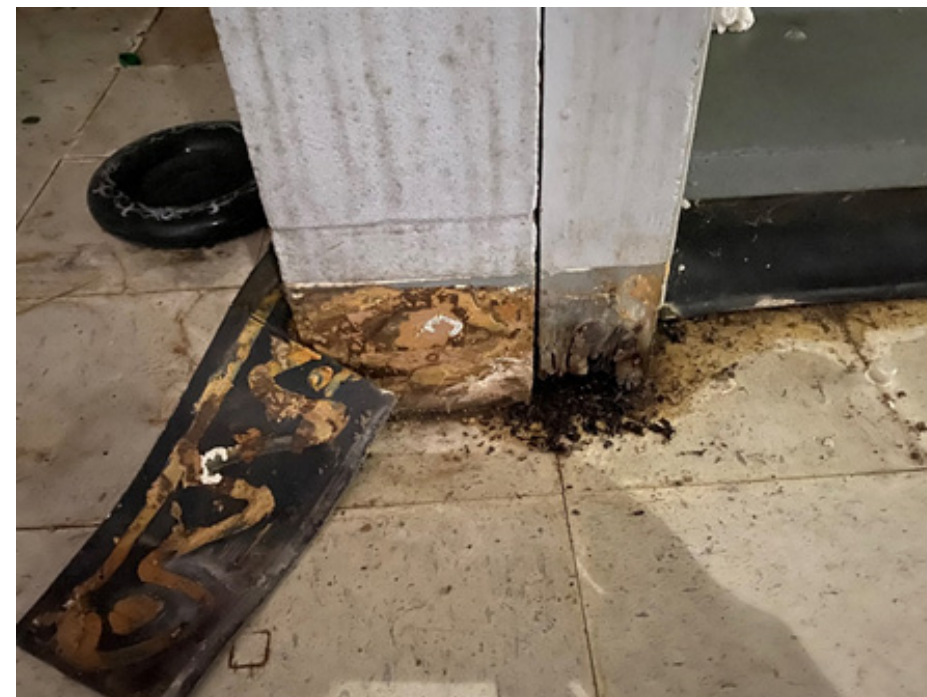
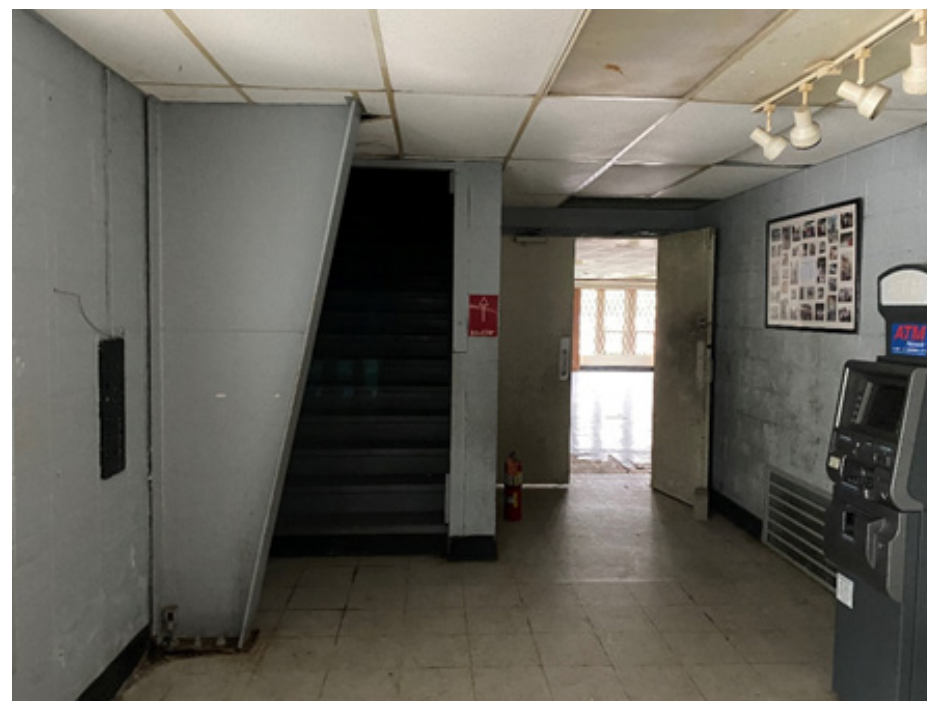
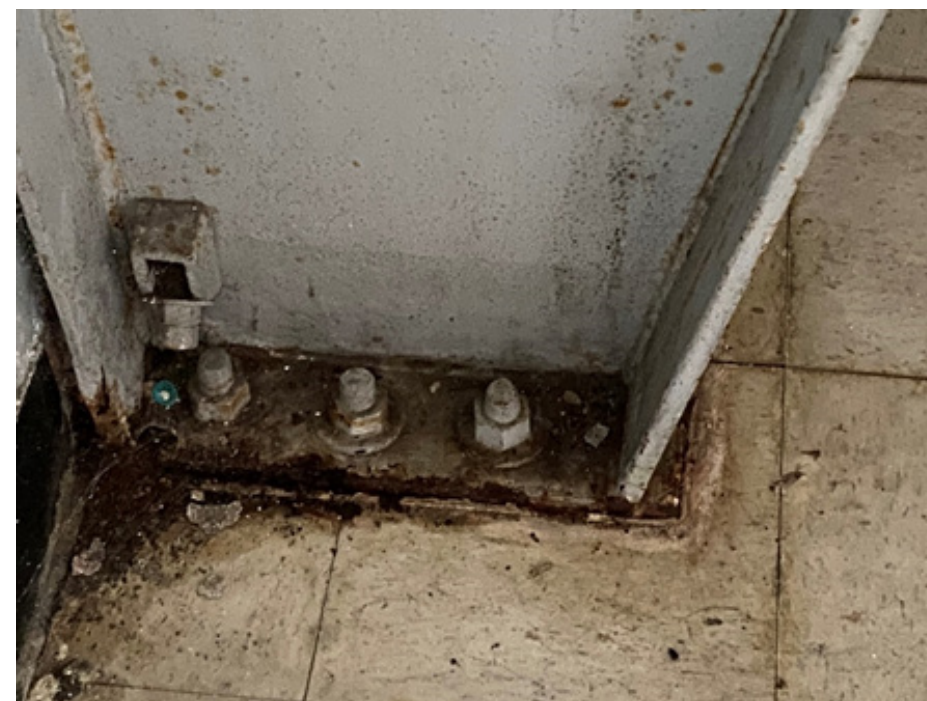
Lobby Area

The lobby area has minimal natural daylight from the entry vestibule. A reception counter meets you as you first walk in and area appears to be appropriately sized. Directly off the lobby area you have access to an office, public bathrooms, gym, meeting room and upstairs mezzanine. Finishes feel dated and in poor shape, primarily from moisture issues and due to age. Ceilings feel low and institutional. Mold and moisture are prevalent within the space.

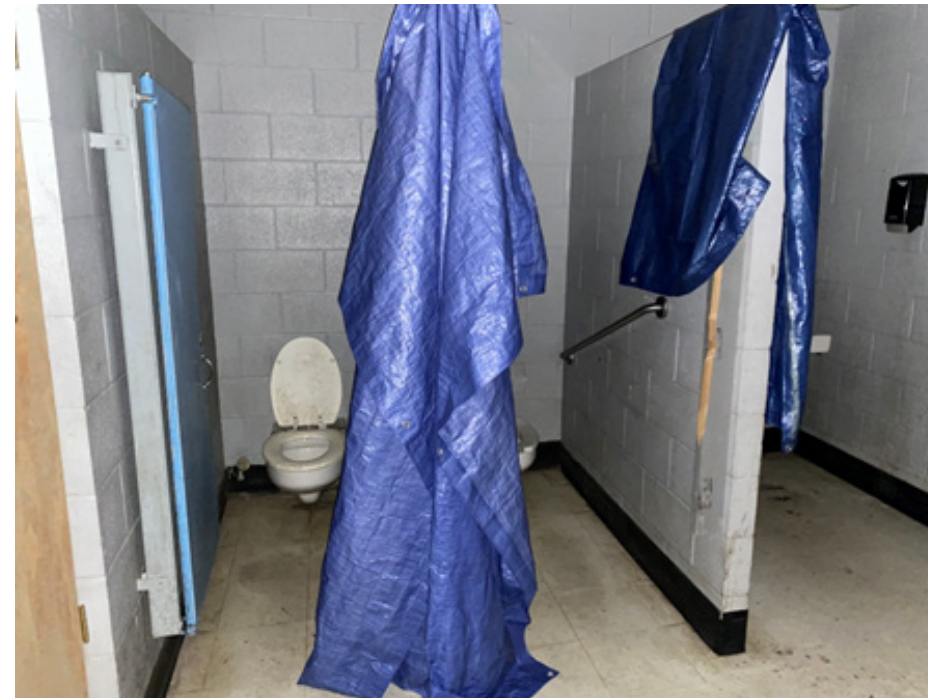
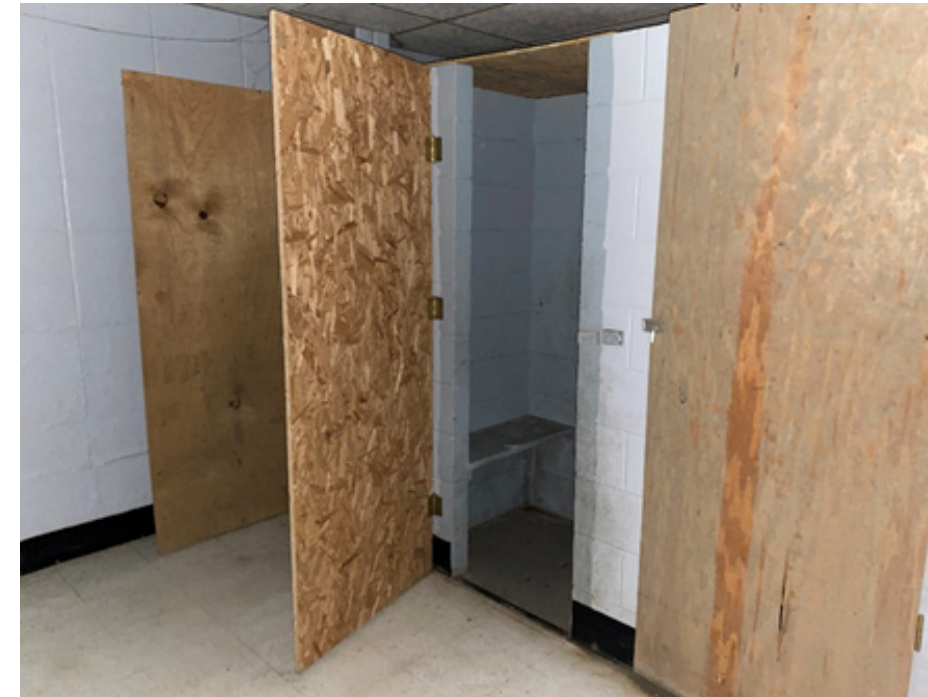
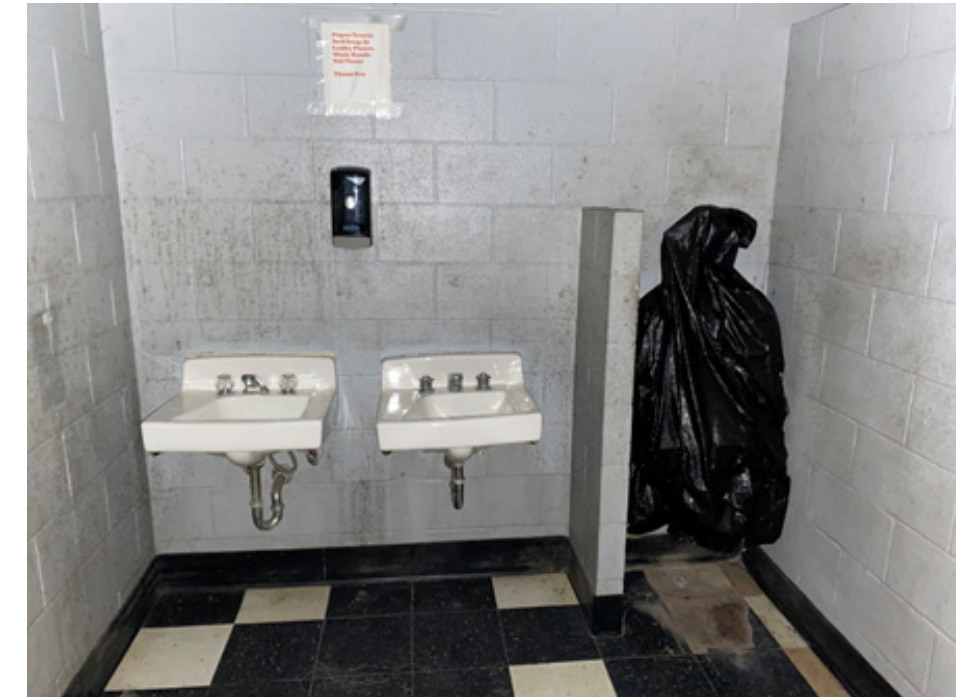
Bathrooms / Locker Rooms

There are two single occupant men's and women's toilet rooms off the main lobby. They do not meet ADA requirements. Adjacent women's/locker area includes three (3) showers, two (2) water closets, and two (2) lavatory sinks. The men's/locker area includes three (3) showers, one (1) water closet, one (1) urinal and two (2) lavatory sinks. None of the showers or toilets are ADA compliant. Current fixture counts would accommodate an occupancy count of 240 people under current code. The size and use of the building would dictate a higher occupancy count and require an increase in bathroom fixture counts.

Overall interior finishes were in a poor and deteriorated condition. Makeshift attempts using tarps and plywood were used to provide privacy at shower and toilet enclosures. Lavatory sinks did not have mirrors or ADA accessible levers. Soap dispensers were also mounted out of reach.

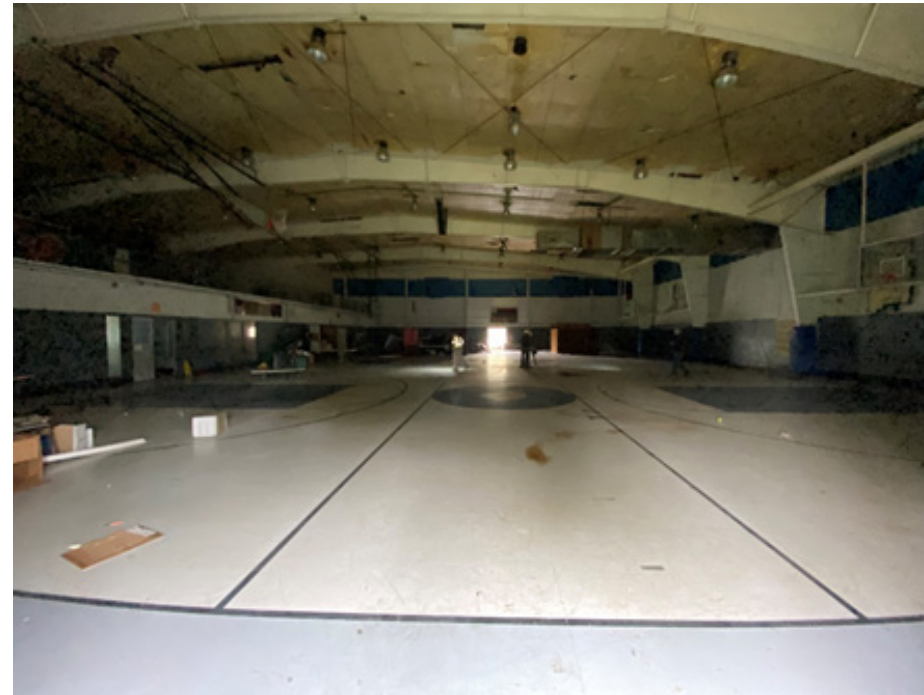
Gymnasium Area

This area is a double height space with exposed structure above. This area contains two (2) $\frac{3}{4}$ length basketball courts with painted concrete floor with striping. Concrete appeared to be in good shape with no observed cracking. Perimeter walls are CMU up to mezzanine height to provide impact resistance. Mezzanine is open to this space from above, providing a viewing platform, although it would be from the end line of the court. Area is lit by high bay light fixtures. Structure is furred out at the base with padding as a safety measure.
