Charlestown Civic Center Assessment

November 12, 2020

HWC
ENGINEERING

EOP Architects

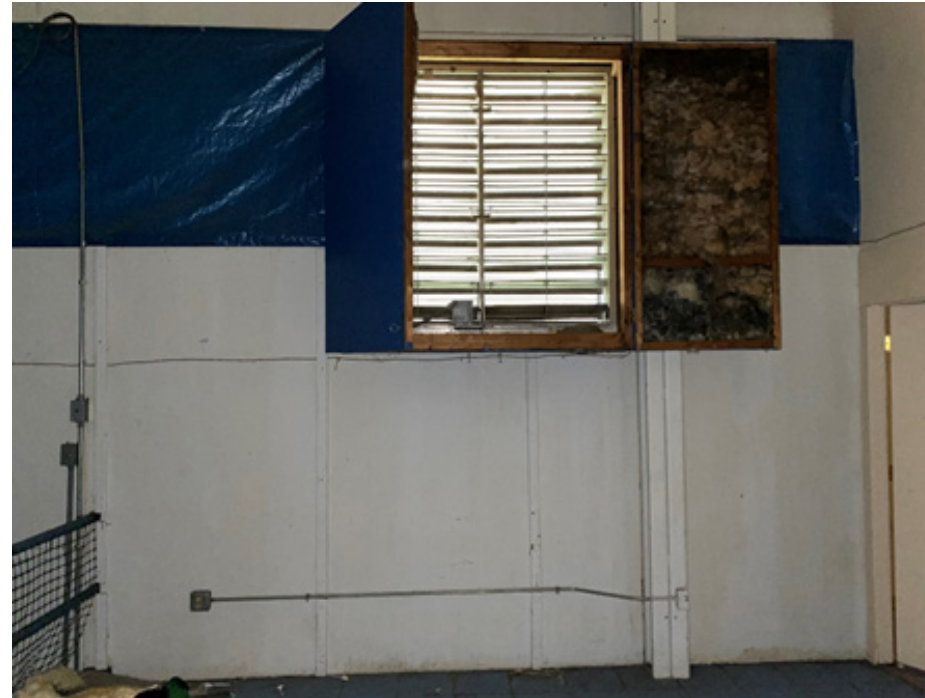
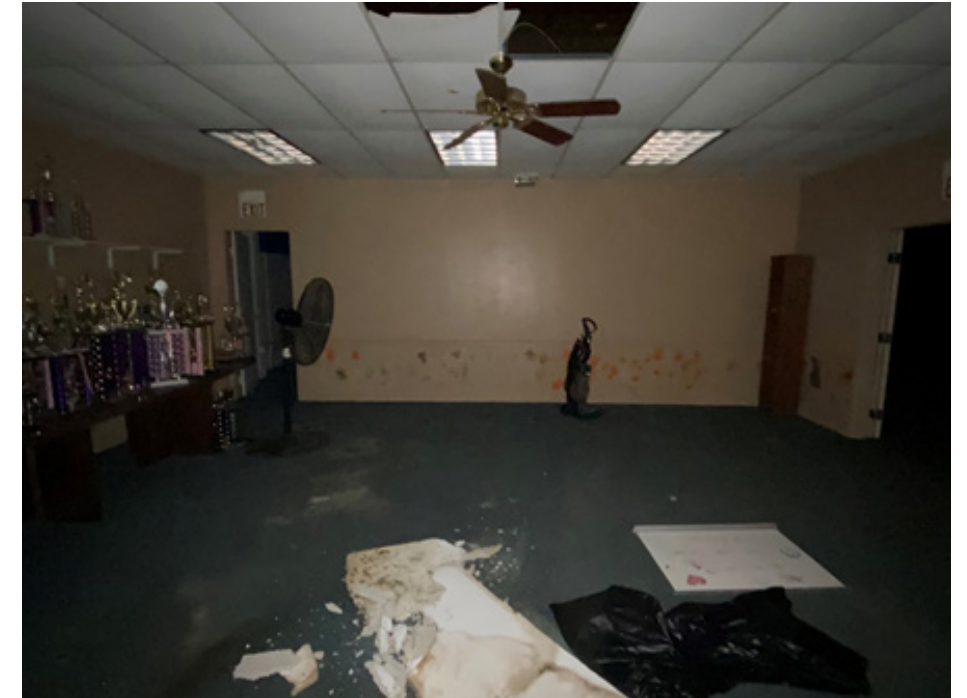
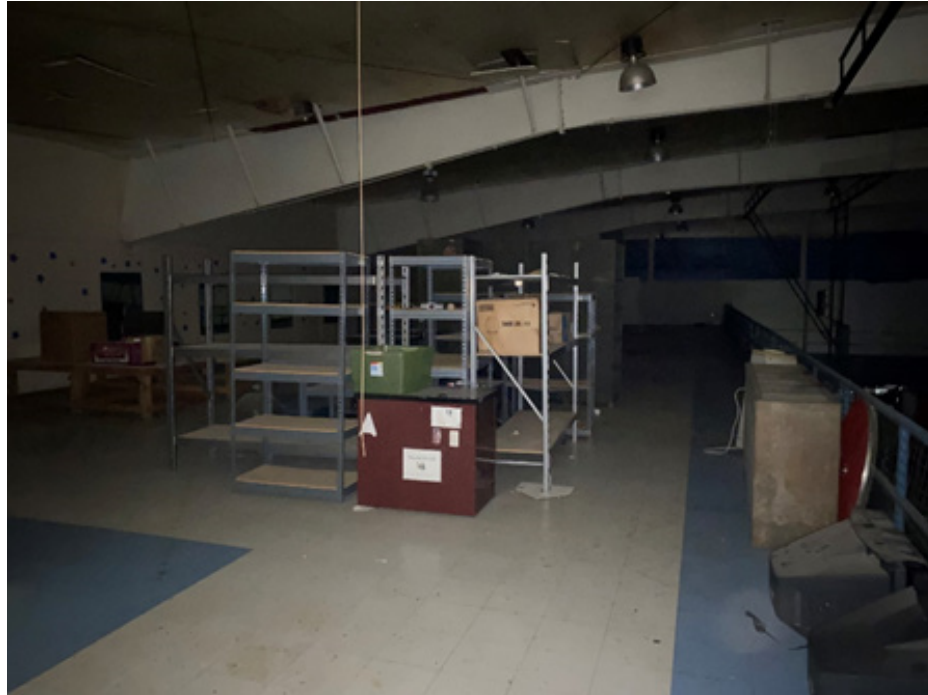
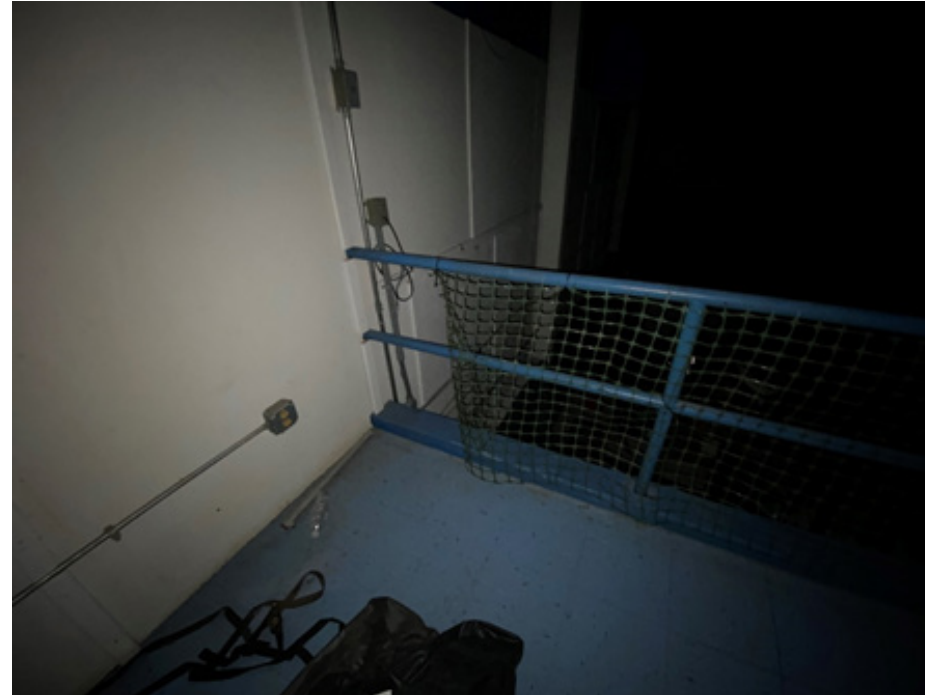
Mezzanine Area

The mezzanine area is approximately 3,000 square feet, overlooks the gymnasium below and was most likely used as a viewing platform. It also appears to have a secondary use as a storage and practice area. Room enclosures were added on each end. One houses cheerleading trophies and may have served as a practice area. The other end was used for storage. Tapered roof structure does become low on one end of the mezzanine. Flooring structure is a concrete deck supported by steel metal joists. VCT flooring largely appeared to be in acceptable condition. Railings are non-code compliant and are a significant safety hazard as one could easily slip through the railings to the floor below. Some active roof leaks were observed, with some structure exhibiting surface rust and pitting. Vinyl scrim covering fiberglass insulation was torn in multiple location along walls.

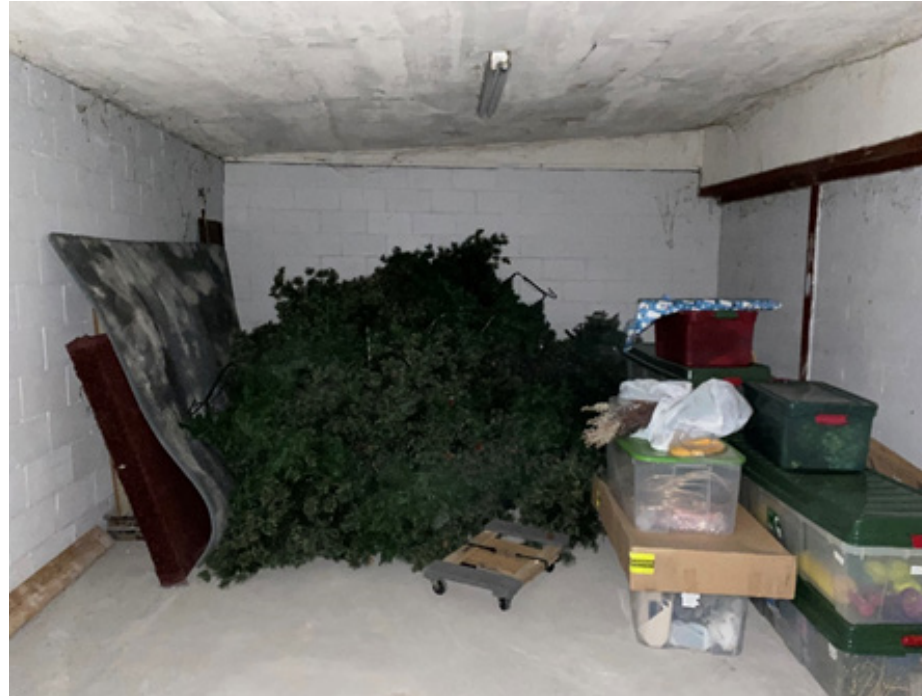
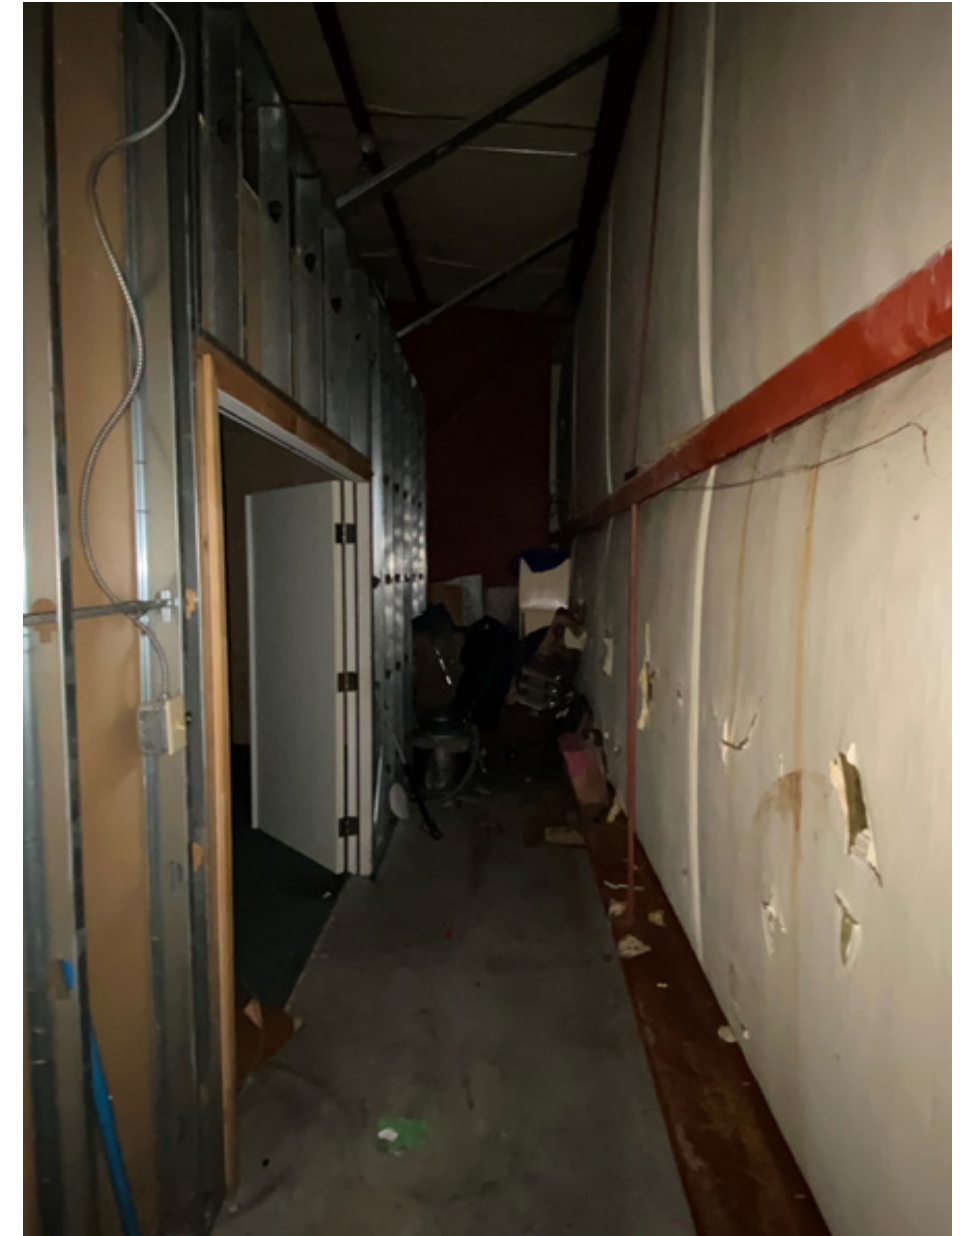
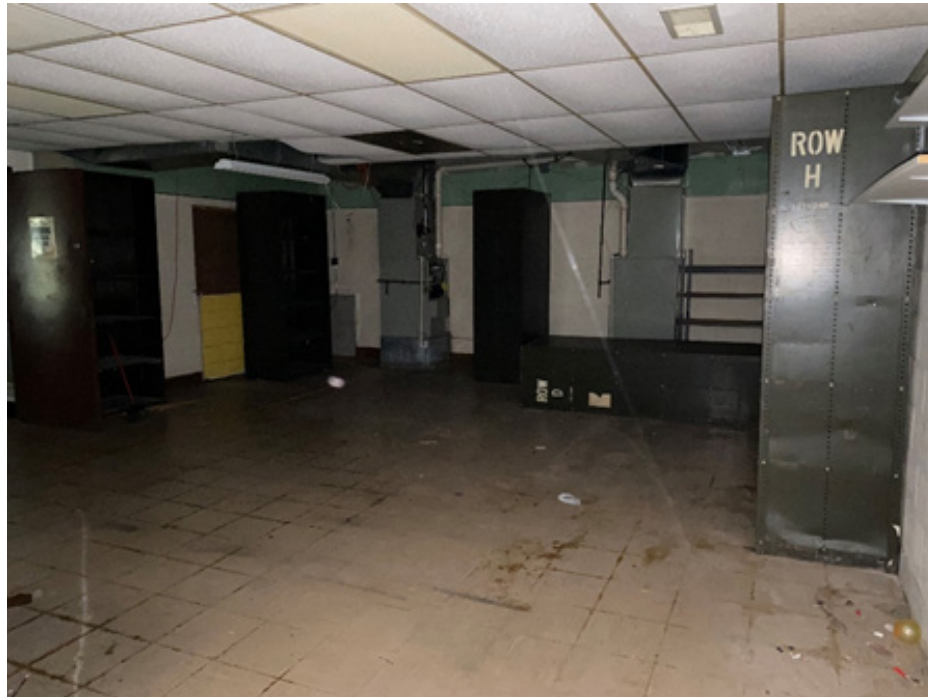
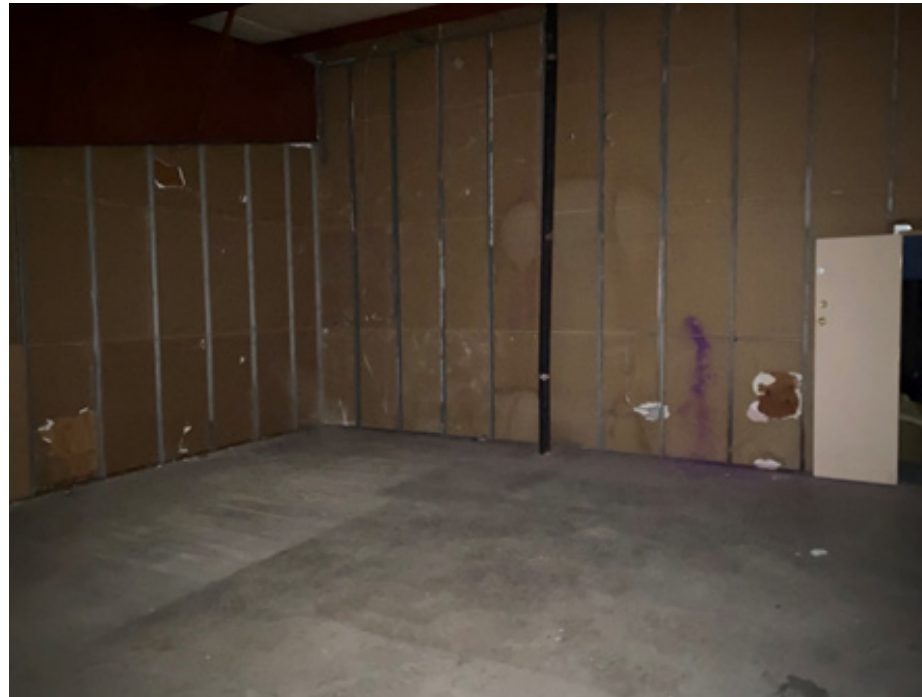
Storage and Mechanical Room Areas

Building has a dedicated electrical room accessed through break-room area. Room houses switchgear and electrical panels. Fire Alarm panel, two (2) interior air handler units which are part of a split system are located within a first-floor storage room. A Wi-Fi router was also found in this area. Storage areas were located on the first floor adjacent to the lobby, under stairs (code violation in current state), in the CMU addition off the Gymnasium floor and in areas of the mezzanine.

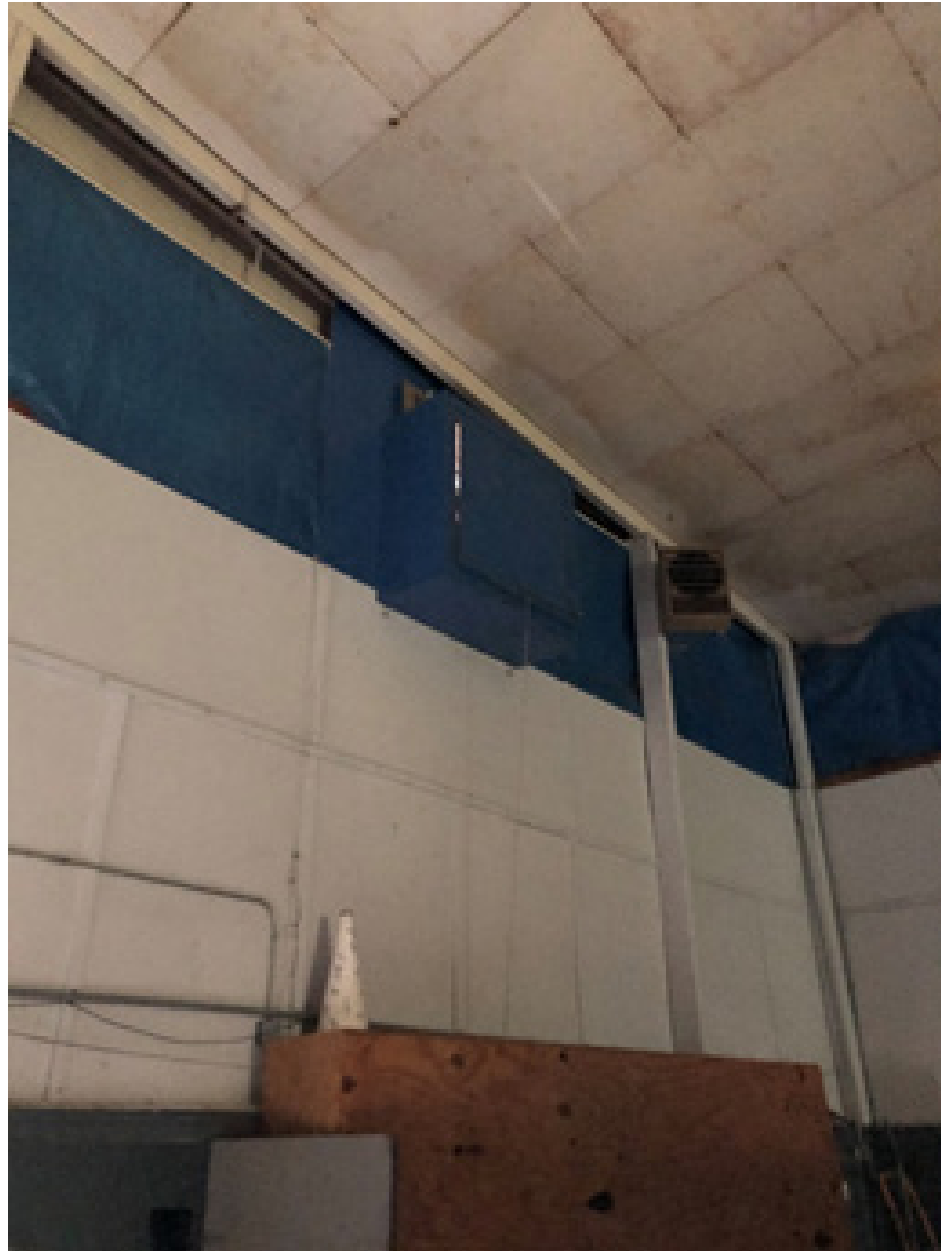
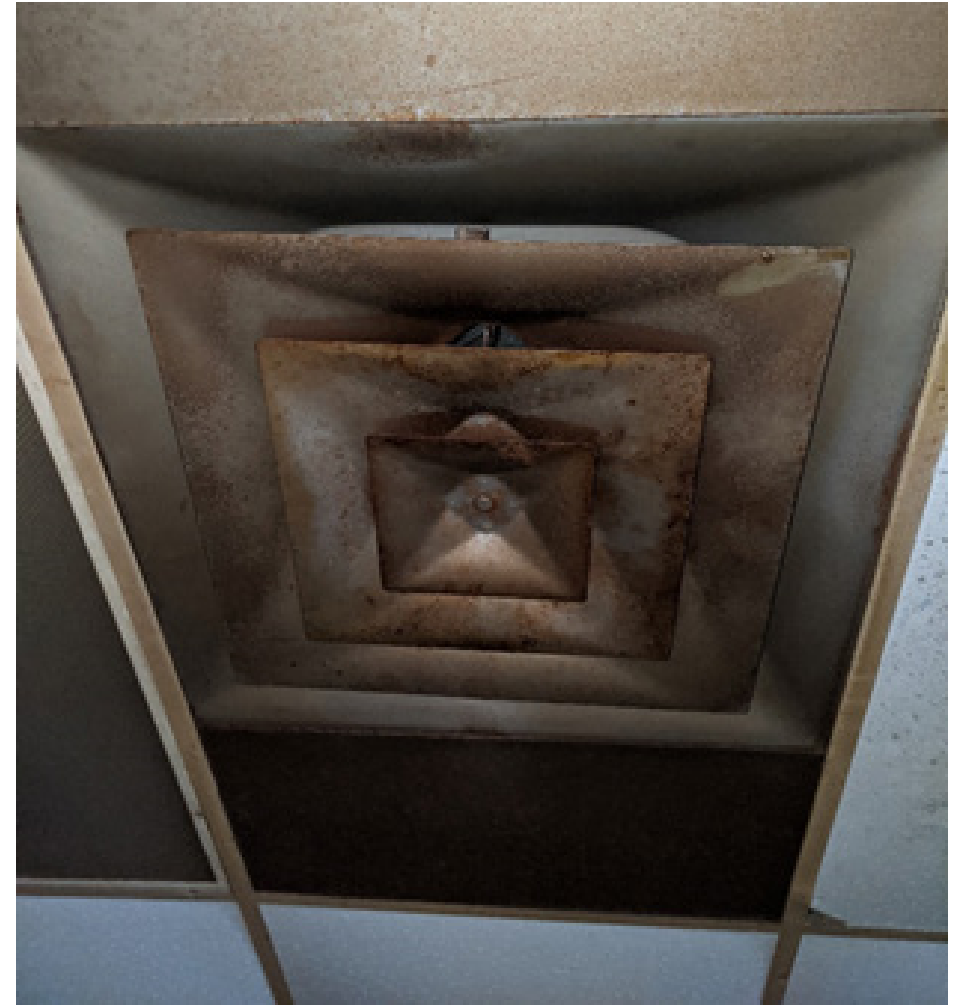
Ventilation is provided through a large in duct fan. The duct is connected to an intake louver on the outside wall and there are diffusers on the outlet of the fan. There is no conditioning of the outside air.

There are two ground mounted air handlers outside of the gym that supply conditioned air across each court. The return is located low on the wall and the supply is located about halfway up the wall. There is exposed ductwork on the outside of the building.

There are offices/restrooms/meeting spaces in the front of the building. These spaces are conditioned by two (2) Trane split systems. The two (2) furnaces are located next to each other indoors and are ground mounted vertical units. The condensing units are located outside towards the entrance of the building.

It is recommended that all existing equipment be demolished completely. The equipment has not been operated for a few years, does not appear to be in working shape, and does not meet current code.

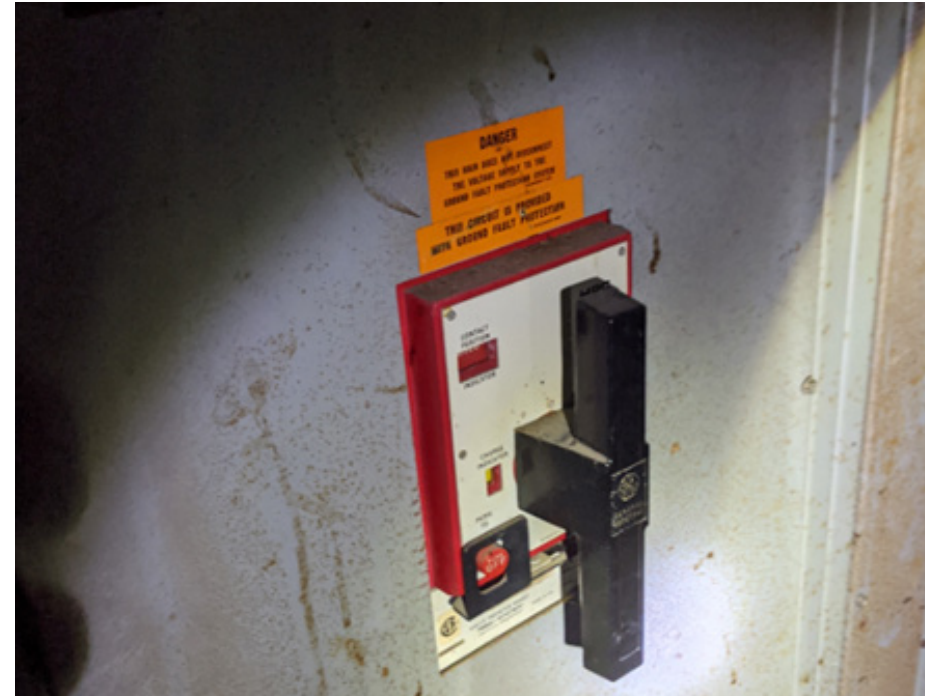
Power Distribution and Wiring Devices

The existing distribution equipment is outdated and damaged. The equipment appears to be original to the building. Water damage and rust were observed as well as standard wear and tear of the equipment. Multiple panels are not properly secured to the walls. The covers of the panels do not conceal the live wiring within the equipment. Due to the age of the equipment, replacement parts are increasing more difficult to find which contributes the difficulty for future maintenance or repairs.

Receptacles throughout the building were observed to be damaged. In addition, bare neutral wires were seen within the panels. Multiple areas throughout the building have wires hanging down from the ceiling or damaged and exposed.

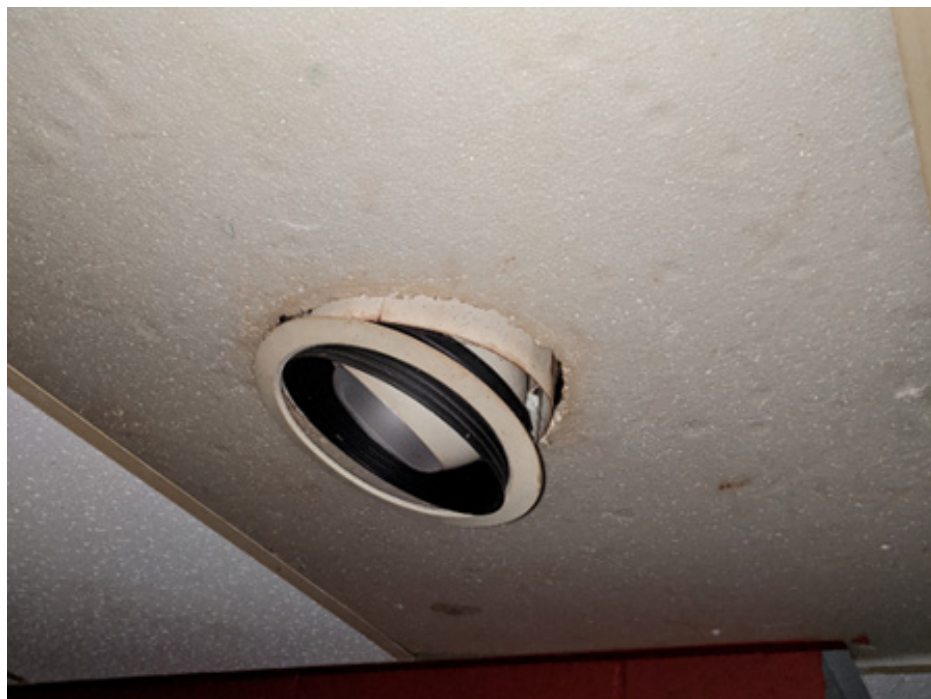
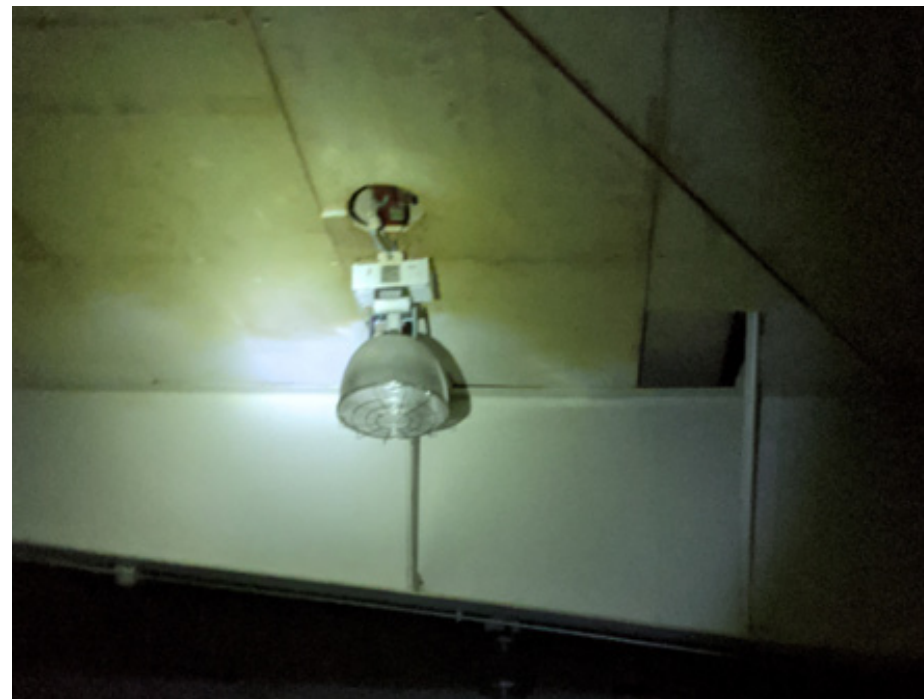
Lighting

The existing light fixtures in the gymnasium are outdated high-pressure sodium fixtures. These light fixtures are difficult to maintain and consumed large amounts of power compared to today's standard of high efficiency LED light fixtures. The lights appear to have been damaged over years of activities as well as roof damage and leaks.

It was observed that several light fixtures are also not secured to the structure and ceilings. These lights were hanging from above by the wiring instead of the housing of the fixtures.

The exterior light fixtures at the main entry do not provide code required coverage for egress lighting do not have battery backup power for egress.

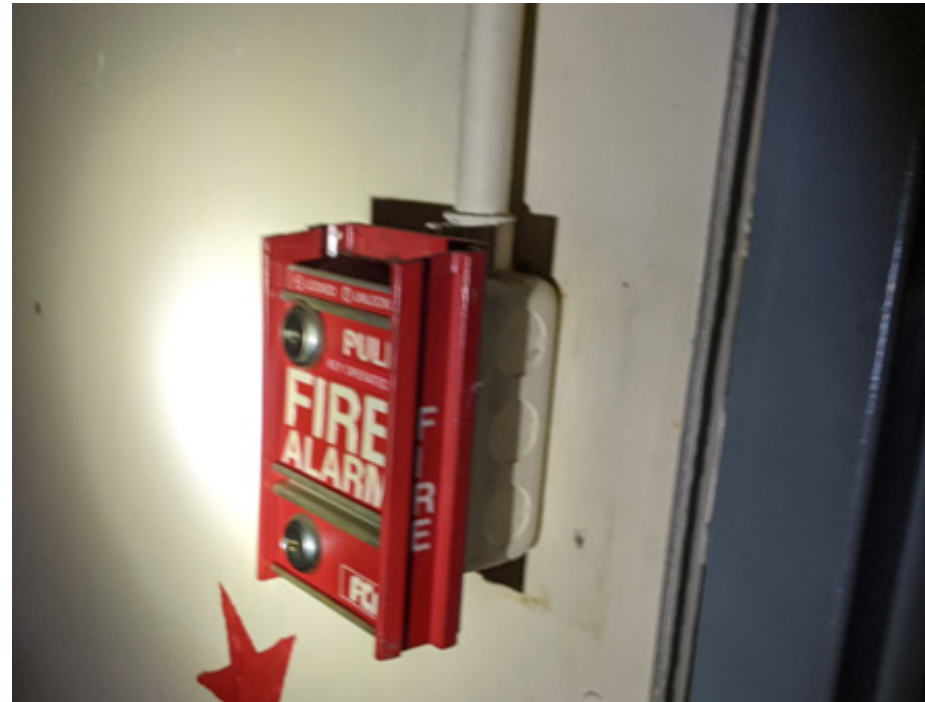
Fire Alarm

The fire alarm system is an FCI (Honeywell) system. It is outdated and does not comply with modern code. The system does not have voice evacuation capability. Also, the manual pull stations do not adhere to ADA standards.

The building lacks full smoke or heat detection coverage for automatic initiation of the fire alarm system in the event of a fire. Also, the building does not have full notification coverage with audio and/or visual means.

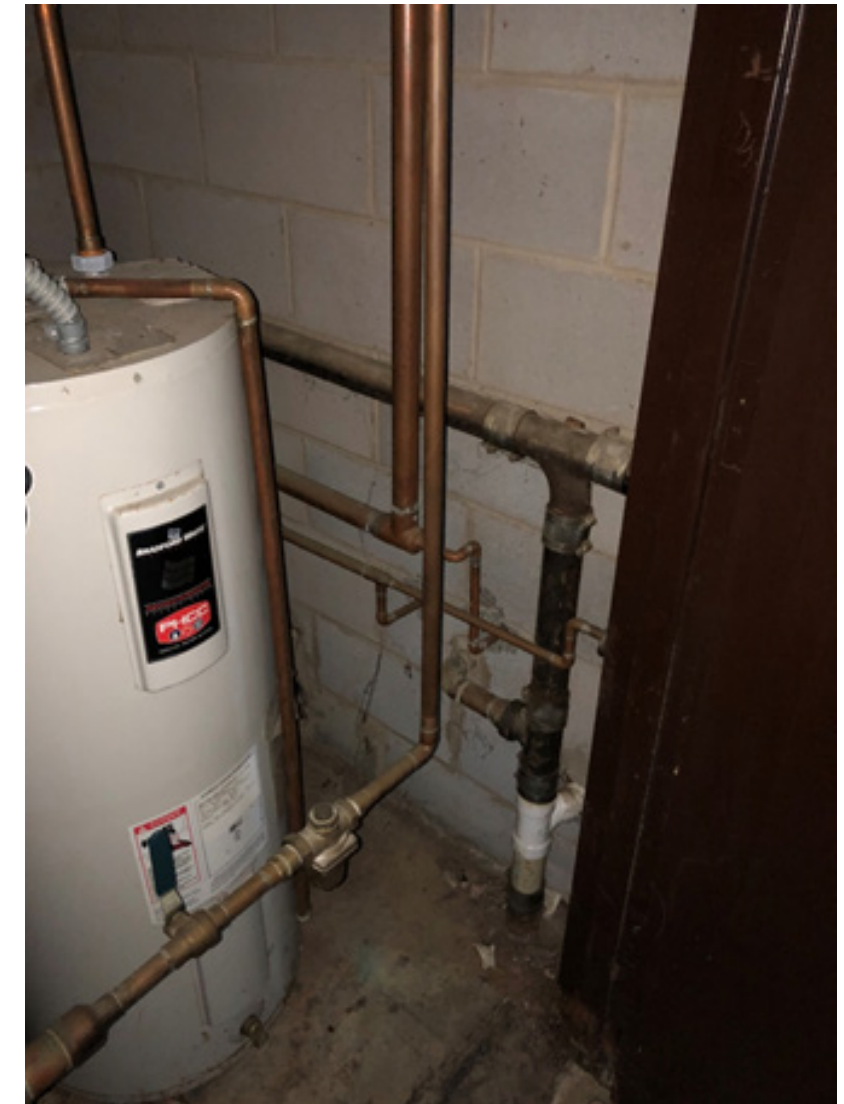
PLUMBING SYSTEMS

All utilities were turned off at the time of the assessment so no systems could be tested. The plumbing fixtures were in poor shape and did not look to be in working order. There is a water heater located between the two restrooms that seemed to be in decent condition. However, this would more than likely need to be replaced as part of the renovation.
