Charlestown Civic Center Assessment

November 12, 2020

HWC
ENGINEERING

EOP Architects

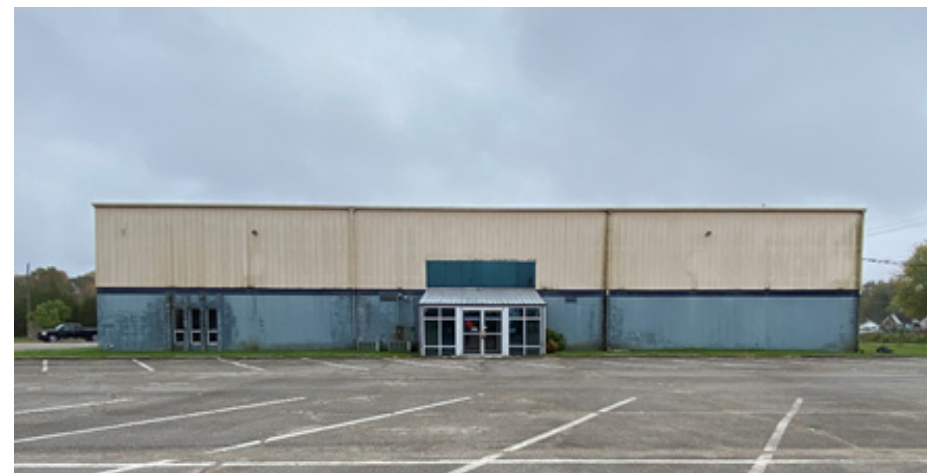
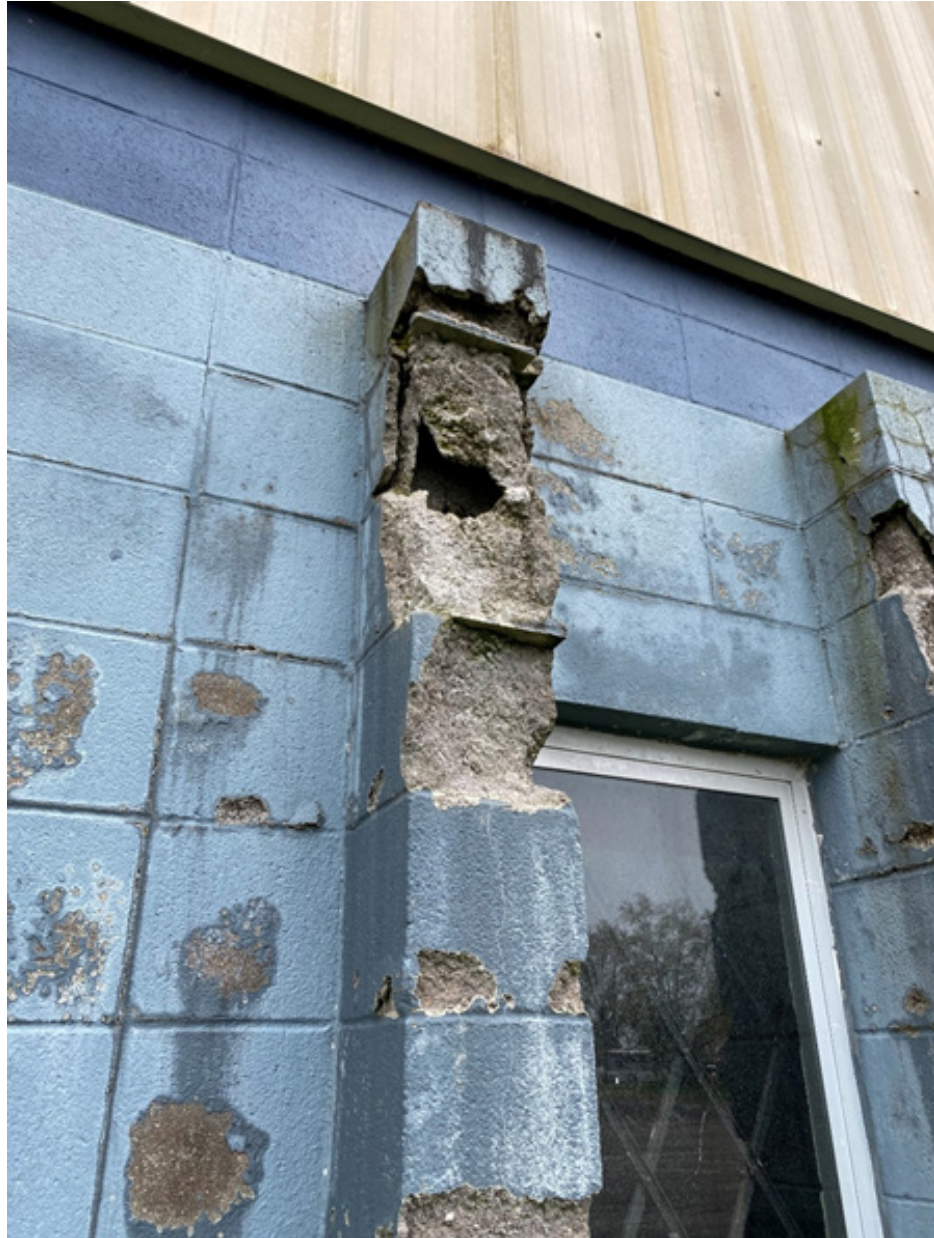
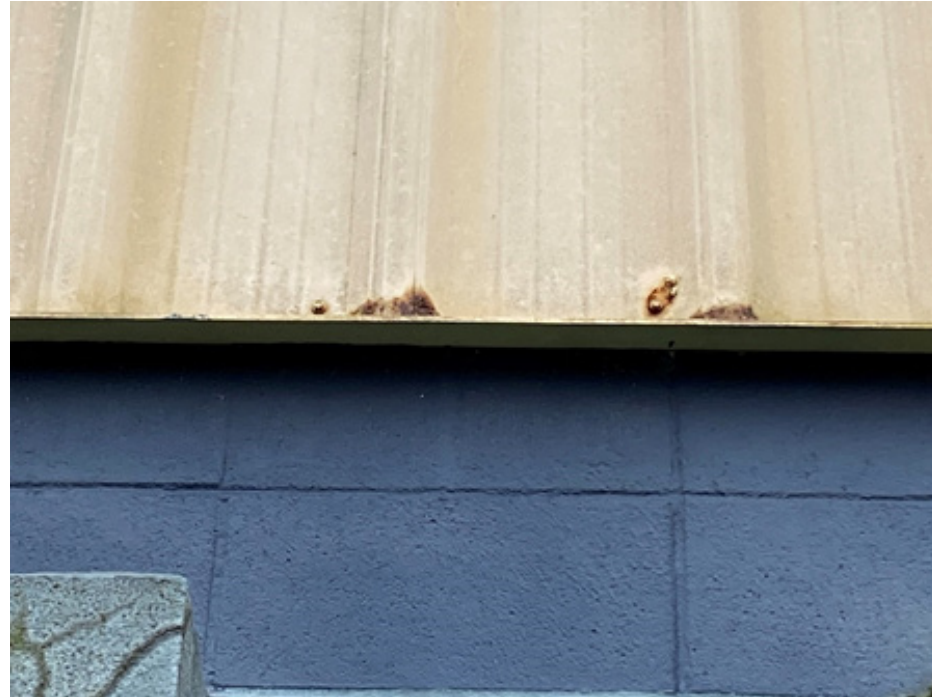
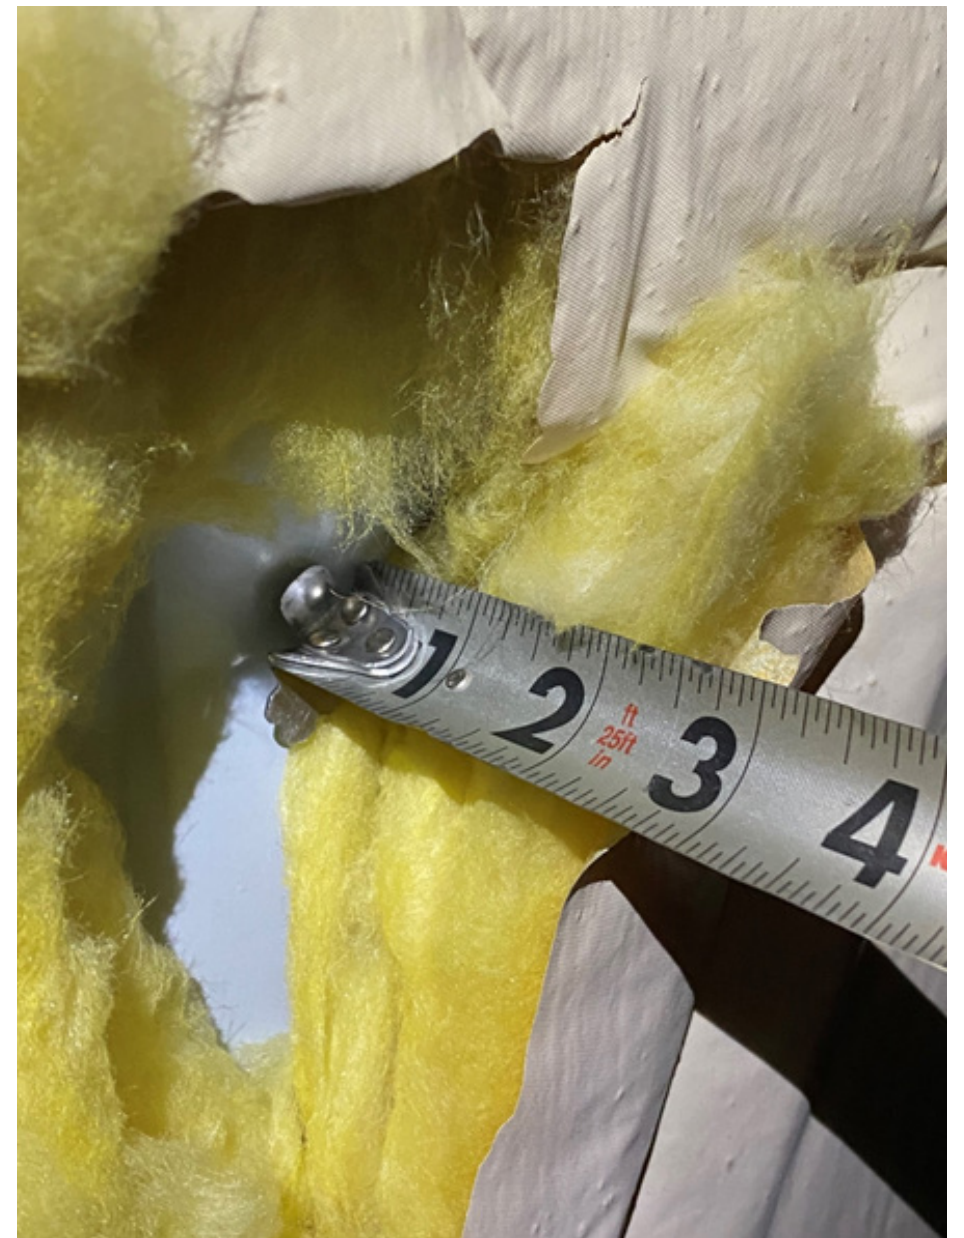
Single width CMU is filled with Styrofoam beads for insulation. It should be noted that this is not a recognized form of insulation by the Energy Code. CMU is in a heavy state of disrepair as wall face in many locations is disintegrating exposing interior core of the block, including base of wall at ground level. This is most likely due to water infiltration and freeze thaw action. Water infiltration is most likely from a number of factors including sloping grade towards building, roof leaks, damaged gutter and downspouts, surface absorption and vapor drive. Paint finish was chalking and spalling from CMU face.

Slim vertical aluminum framed punched widow openings with operable bottom sash provided some daylighting to large interior meeting room. Glass was clear single pane with no low-e coating. Windows are thermally inefficient and would not meet current energy code.

The exterior finish is steel vertical formed metal panel with exposed fasteners, directly attached to structural steel horizontal purlins. Wall insulation consists of 2" of fiberglass with vinyl scrim, which also serves as the interior finish. Insulation does not meet current energy codes. Finish was chalking and rust corrosion through the panel were evident at multiple locations.

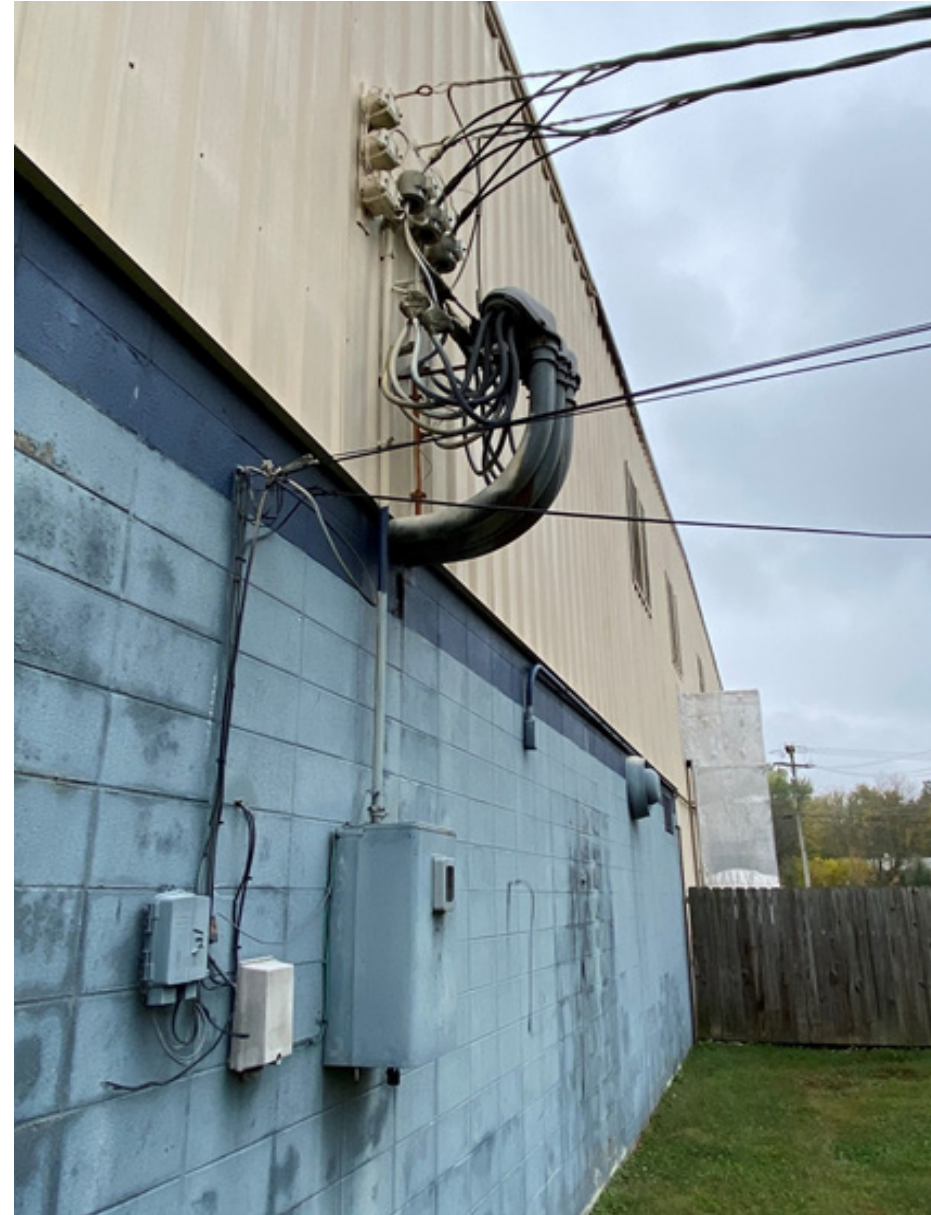
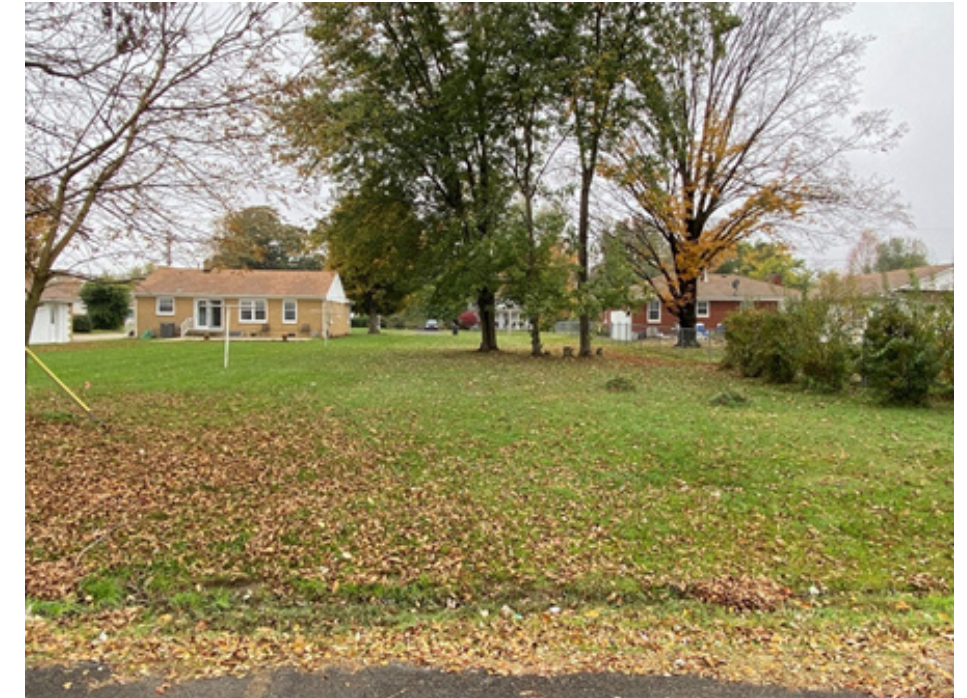
The Side (southwest) elevation faces the rear yard of one-story single-family homes. Façade has same materials as front façade with similar issues. Grading is also an issue on this side, which is slightly above interior finished floor and bottom of metal wall panels. Surrounding grade was also not draining properly with ponding water observed against the building. This has caused the metal panel bottom sill flashing to deteriorate and exposed fasteners to completely fail. Bottom of panels are curling due to no positive attachment. Panels could be moved several inches with minimal pressure applied. A pair of hollow metal doors were exhibiting signs rust and had to be secured via chain. A series of five (5) through wall louvers with hinged closures panels on the inside were most likely used for cross ventilation on temperate days. No mechanical fans were observed on the interior and closure panels are hard to access due to height. Most of the building utility services are located on this side of the building. Electrical is fed overhead from three (3) pole mounted transformers. Telecommunications also enter the building from overhead, however underground telecommunications service appears to be located in close proximity to the building. Three (3) underground water meters pits are also located on this side of the building. A single on grade air handling unit (AHU) is located within a fenced-in enclosure. A single wall pack mounted light has a broken lens cover. An easement between two houses also occurs on this side of the building leading to Monroe Street.

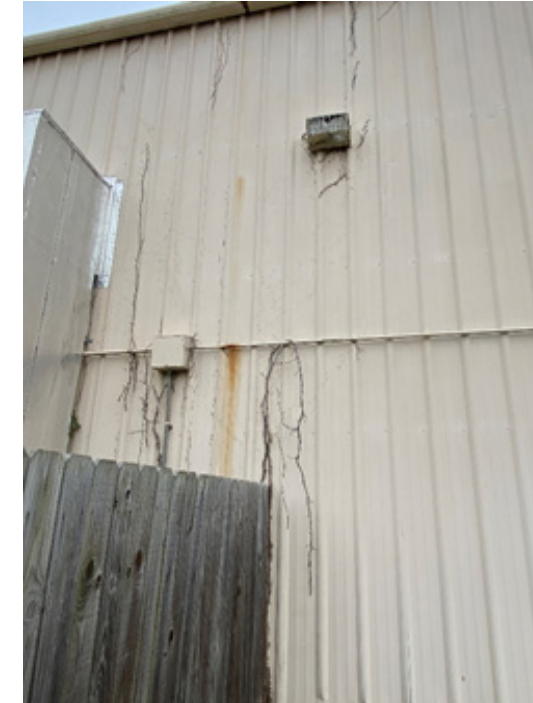
Rear Facade

The rear (southeast) elevation faces Steve Hamilton Drive . Façade is made up entirely of vertical steel metal panel with exposed fasteners. Panels are exhibiting the same issues of deterioration as the rest of the building. A single through wall louver is located on the center of the façade. Gas service to the building is also located on this side. (2) (AHU) units are located at grade surrounded by wooden fences. Two light wall packs have broken lenses.

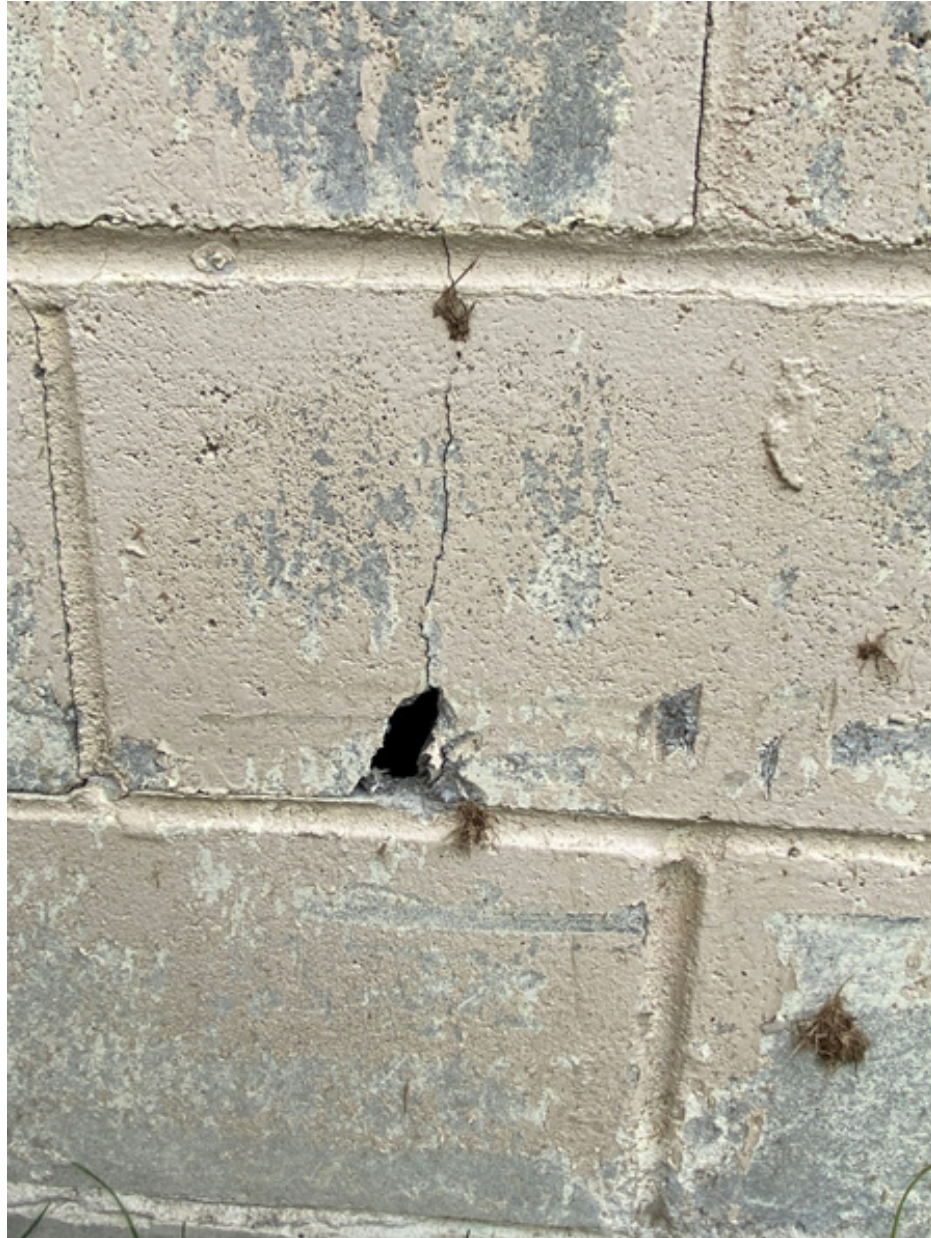
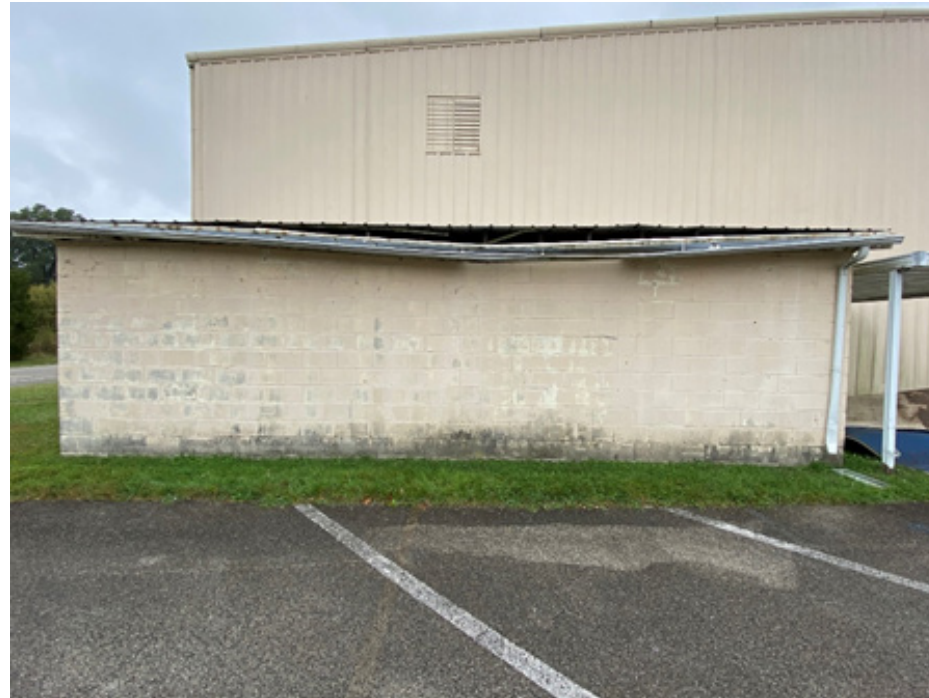
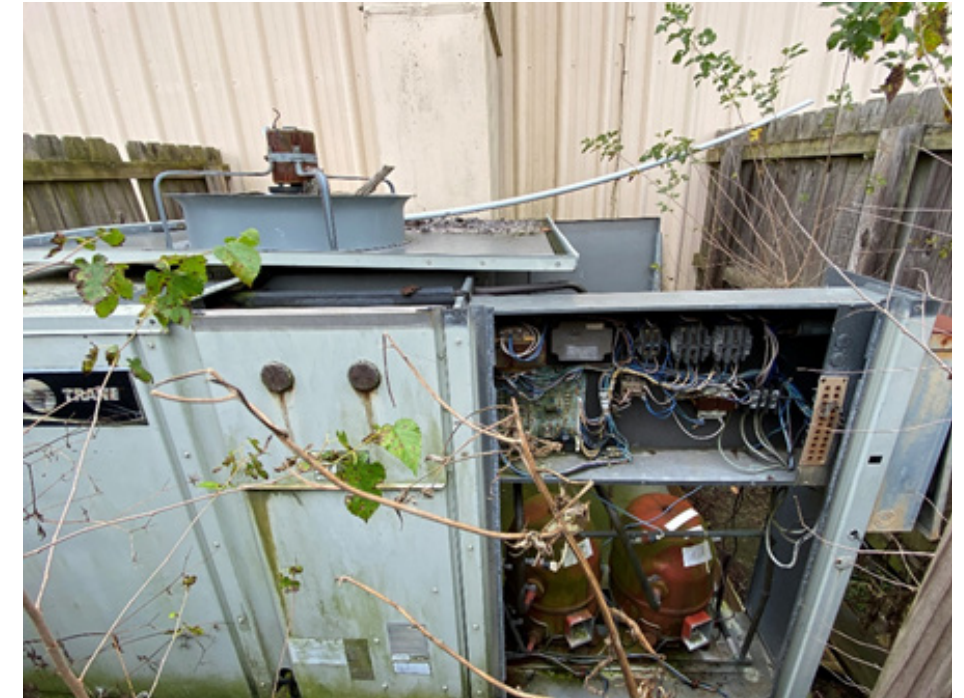
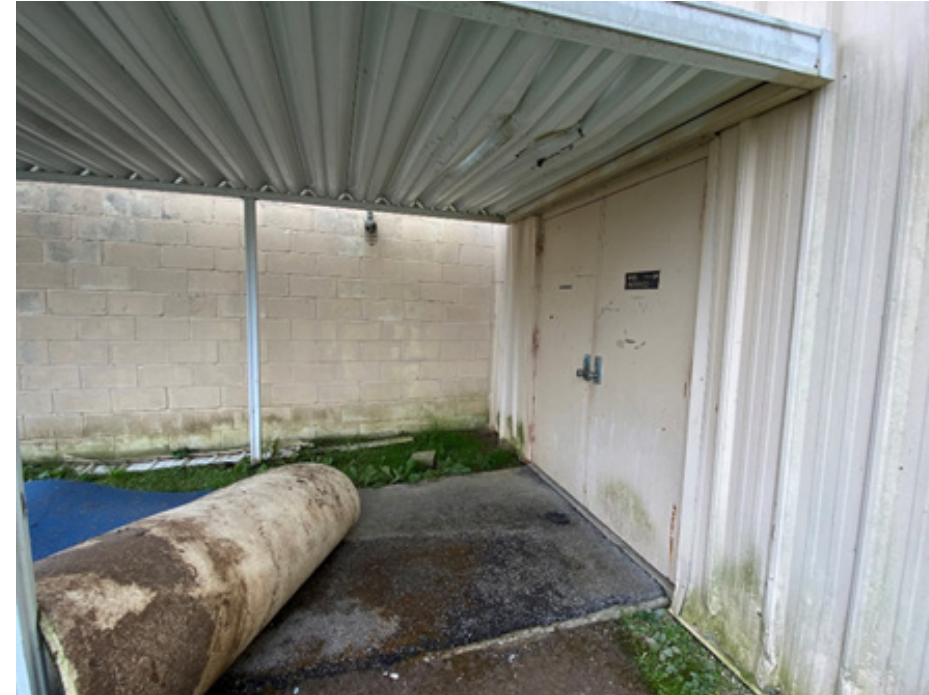
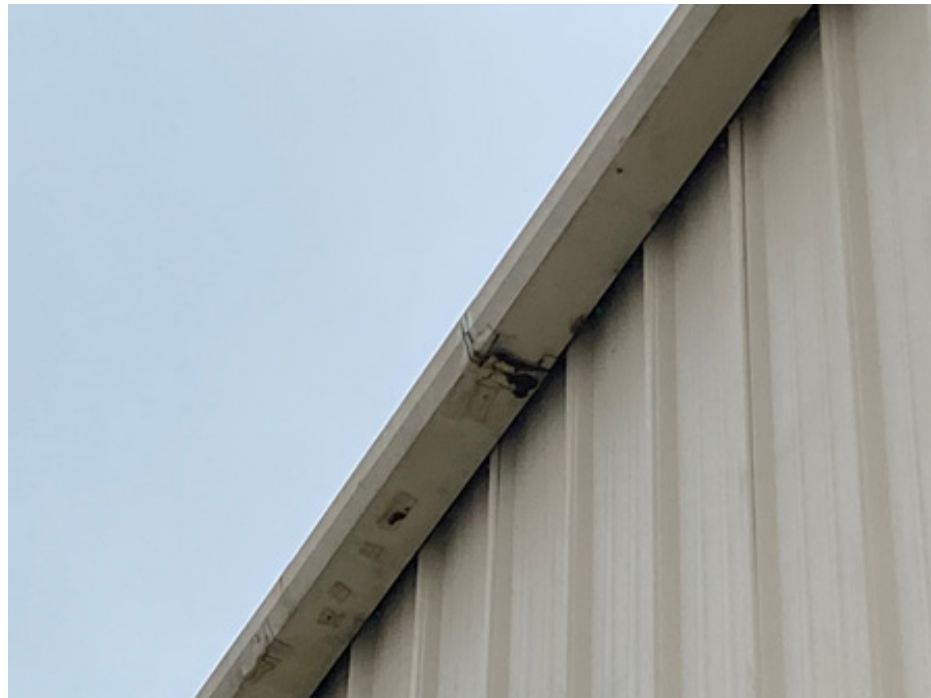
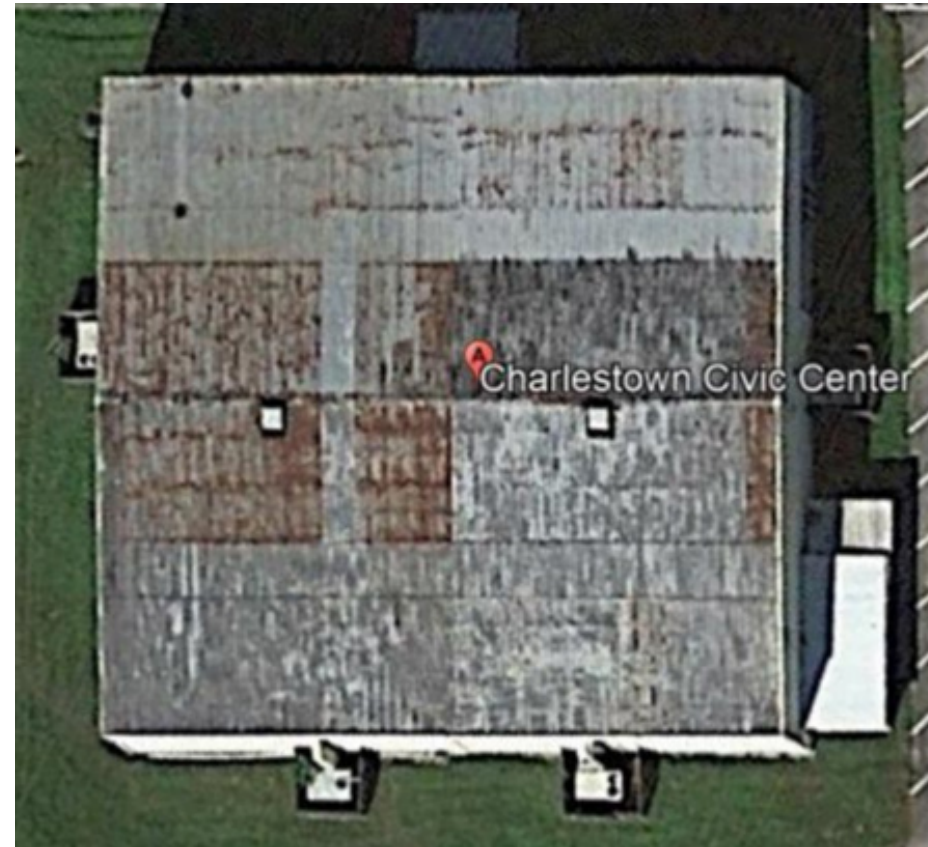
Side Façade Facing Parking lot

The side (northeast) elevation has same materials as front façade with similar issues. Two (2) through wall louvers are located on this elevation. One (1) (AHU) is located at grade surrounded by a wooden fence. A pair of hollow metal doors are secured with a chain. Side gym entry Doors are covered by an aluminum canopy leading to the parking lot. Canopy appears as if it had a large impact as roof panel is dented and cracked. A small one-story load bearing single width CMU addition has visible cracking and holes. CMU does not appear to have grouting or insulation. Roof structure is a single slope on wood rafters and decking. Note, combustible construction is not allowed in Type IIB construction. Fascia has failed along the leading edge of the roof.

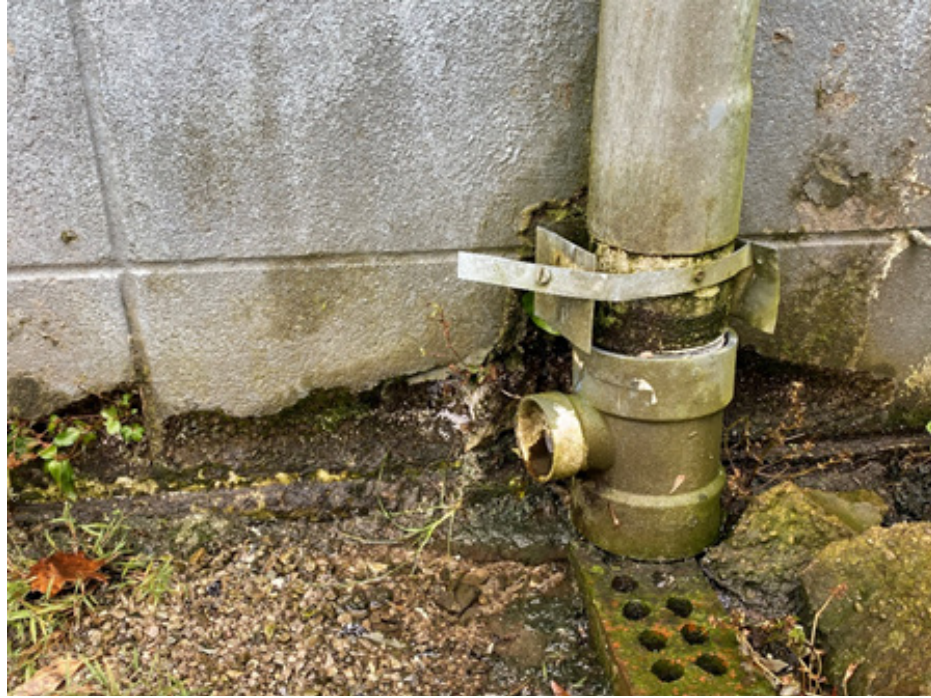
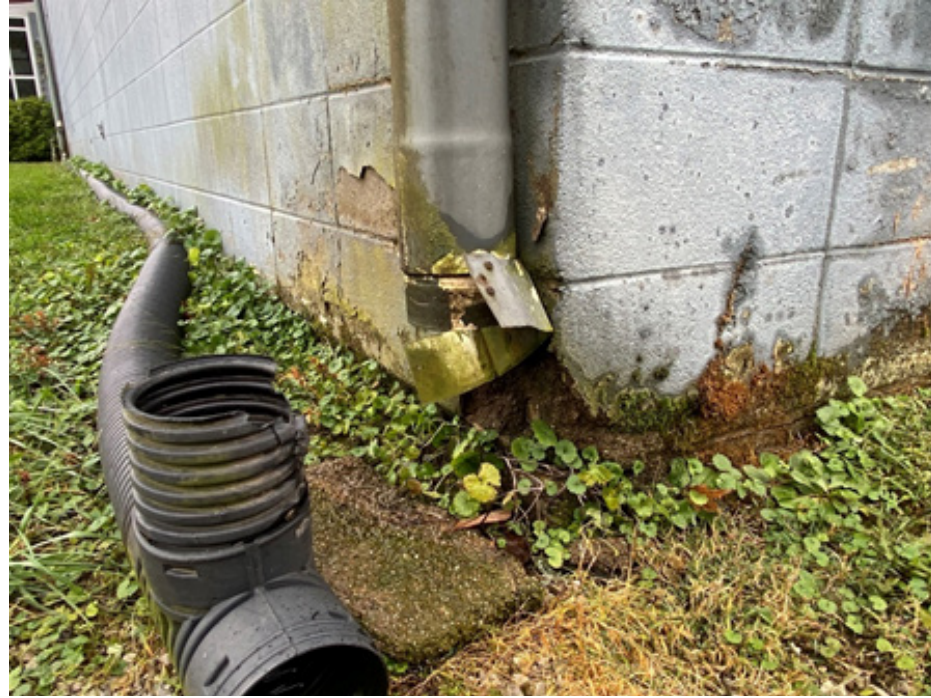
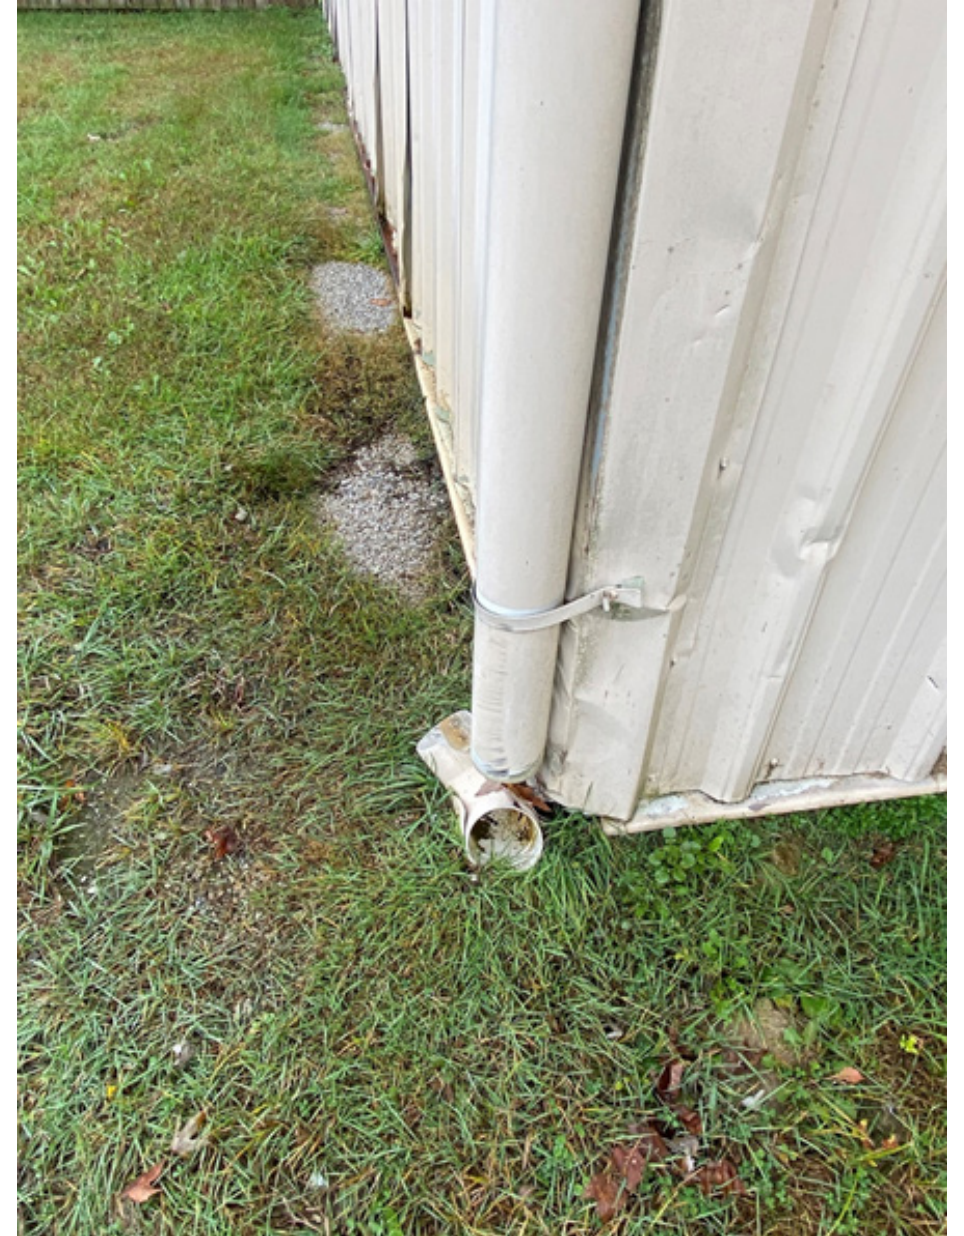
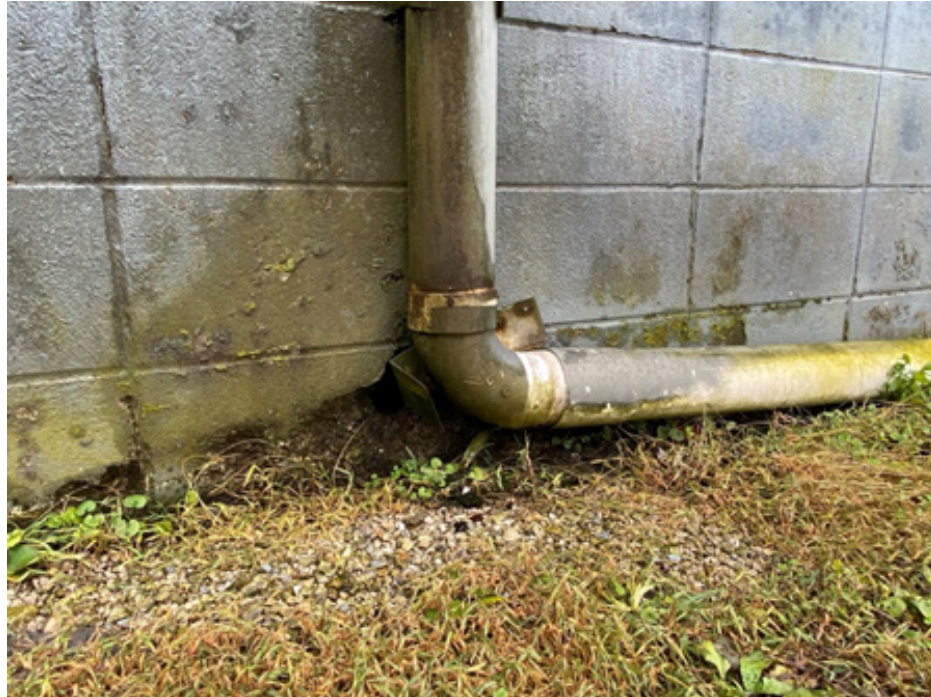
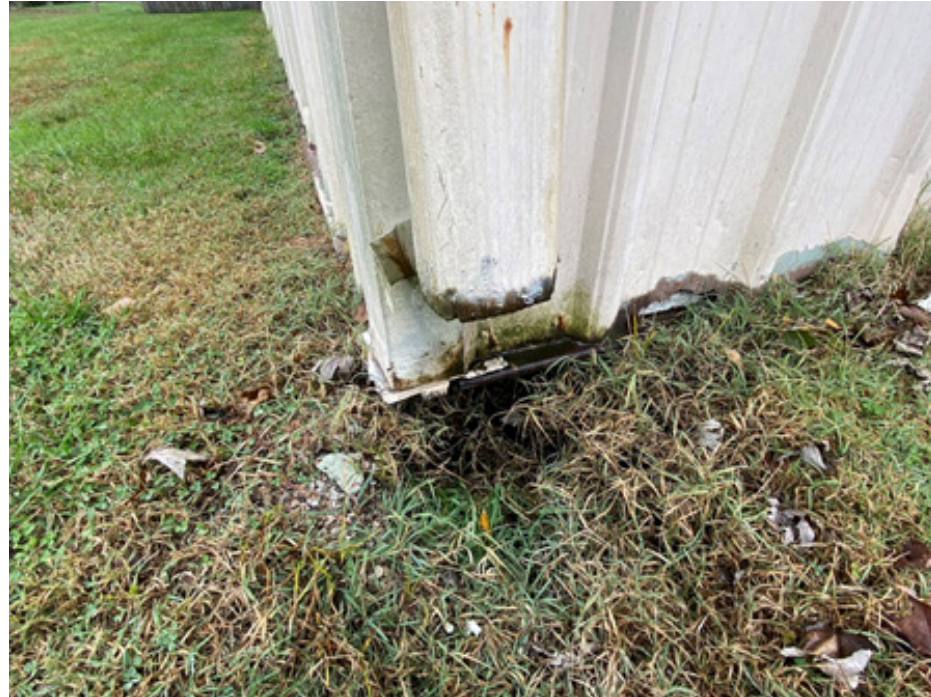
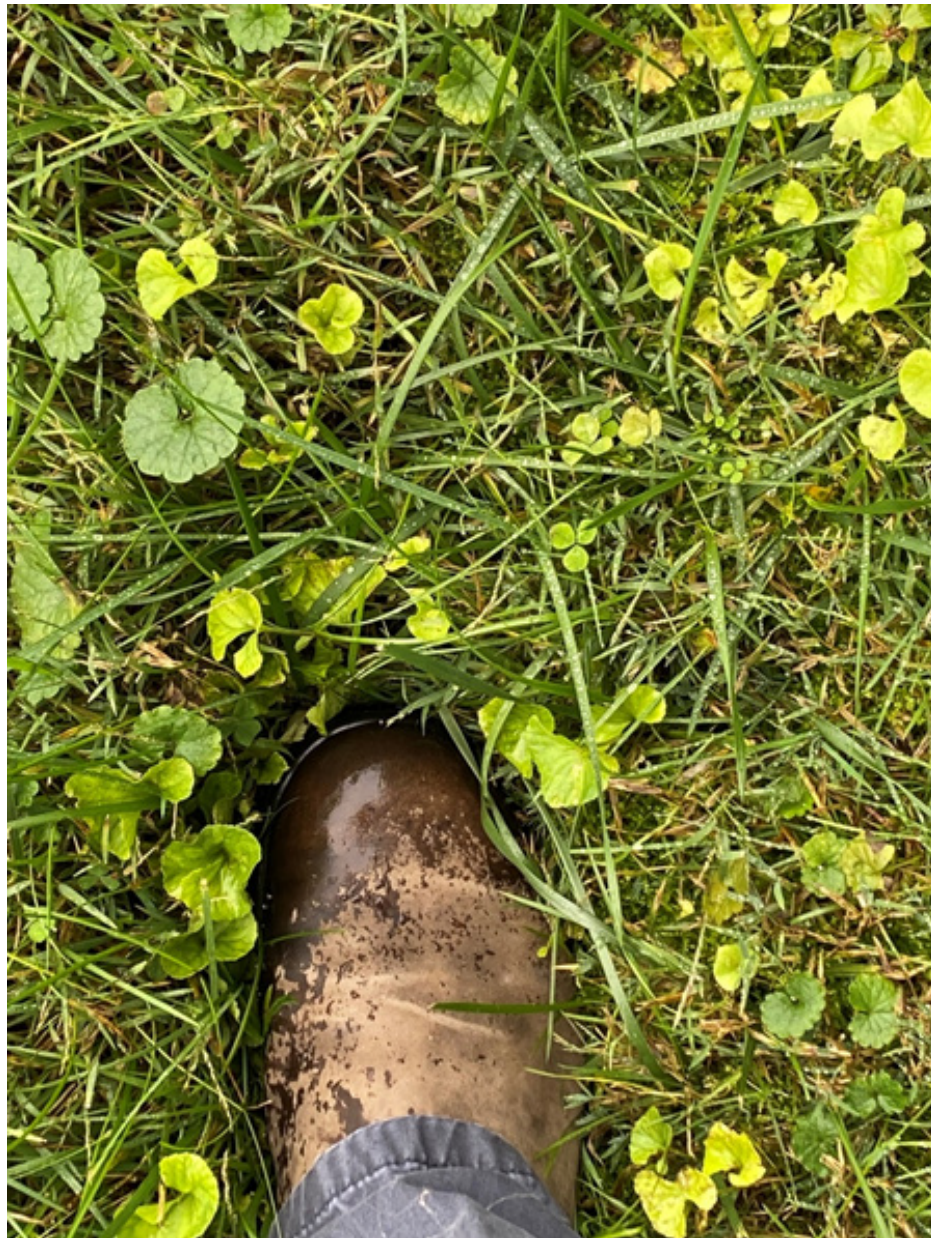
Roofing

Roof appears to be a 3/12 gabled roof pitching to two sides. The roof is painted steel roof panels with exposed fasteners. A visual inspection was not able to occur at the time of the assessment due to lack of access and safety concerns due to the current condition of the roof. However, from aerial photography, city commentary and interior conditions, it can be reasonable inferred that the roof is failing and beyond its serviceable life. From satellite photos it appears that multiple attempts have been made to repair the roof over the years. Severe rusting of panels is also evident. Daylight was visible through the roof from one interior location and visible water damage was evident at multiple locations.

The main roof drains to continuous gutters running the entire length along the bottom edge of the roof. The gutter appears to be properly sized to accommodate the size of the roof. Gutters had visible holes and rust deterioration and were visibly leaking at the time of the inspection. Downspouts are dented in many locations and leaking at joints. Boot connections at the bottom of downspouts are missing or heavily damaged, causing water to collect at the base of the building. This has helped contribute to visible failure of CMU and metal panels along the base perimeter of the building, allowing for water migration into the building.

Side addition has single sloped metal panel roof with exposed fasteners. It appears that the roof has a less than 3/12 recommended minimum roof slope. Deck is supported by wood roof rafters and decking. Front fascia and gutter along the leading edge has failed and is visible hanging exposing the ends of the wood roof rafters and failed wood decking.

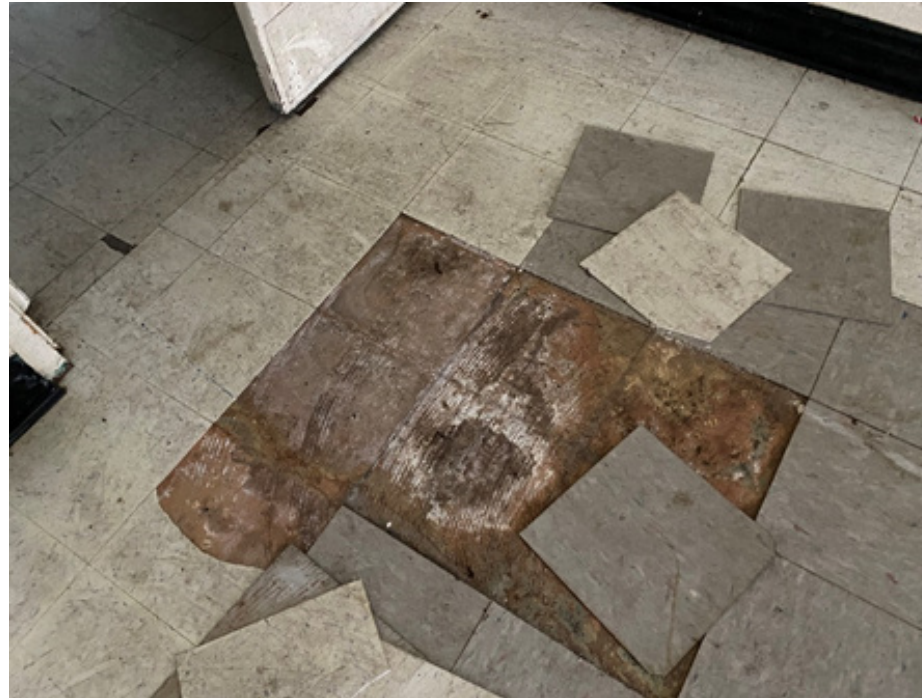
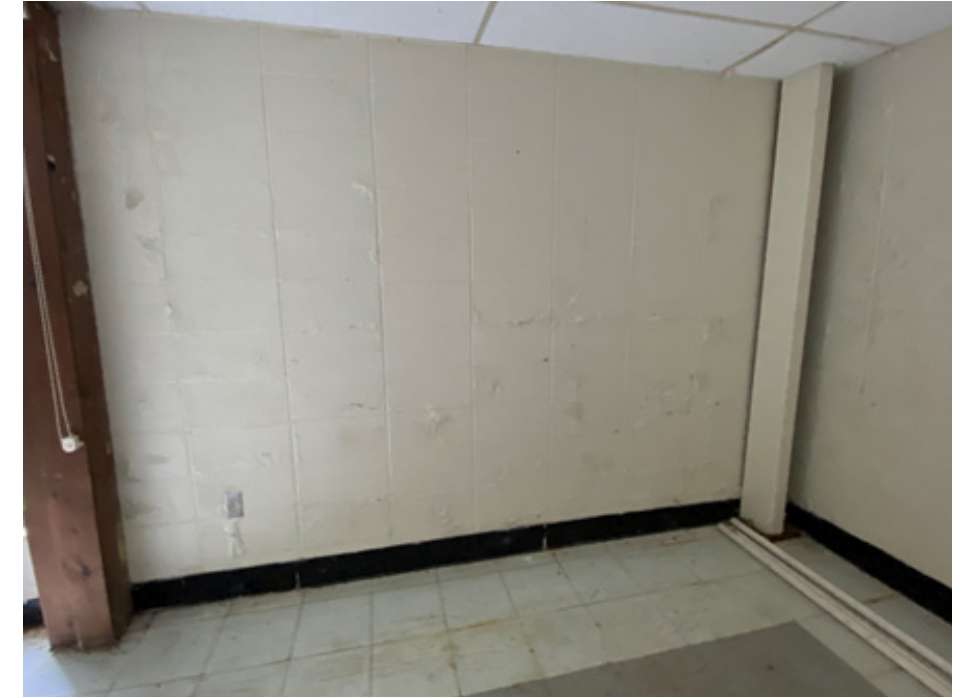
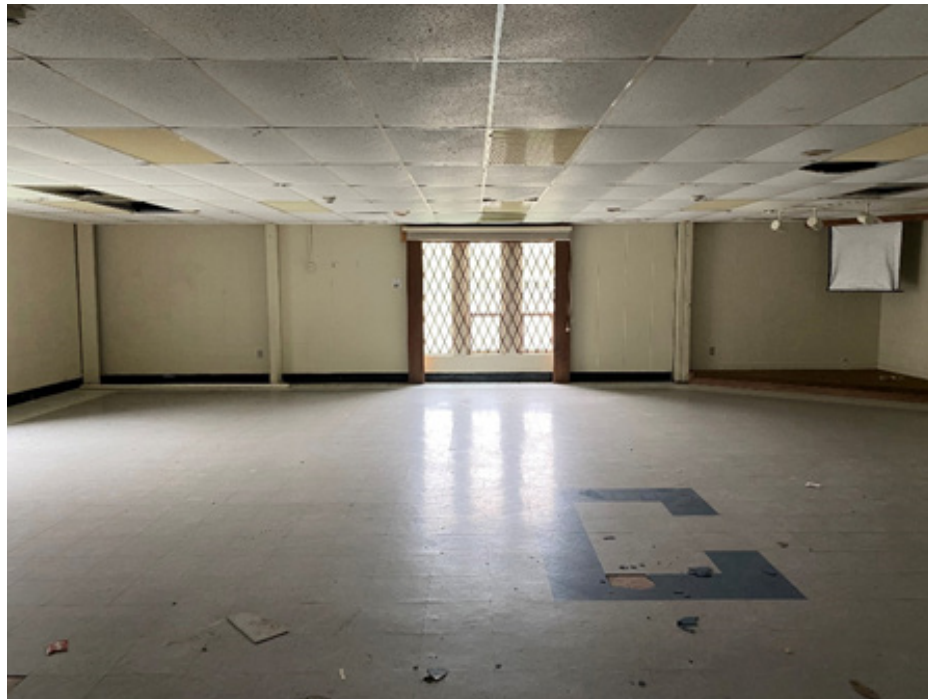
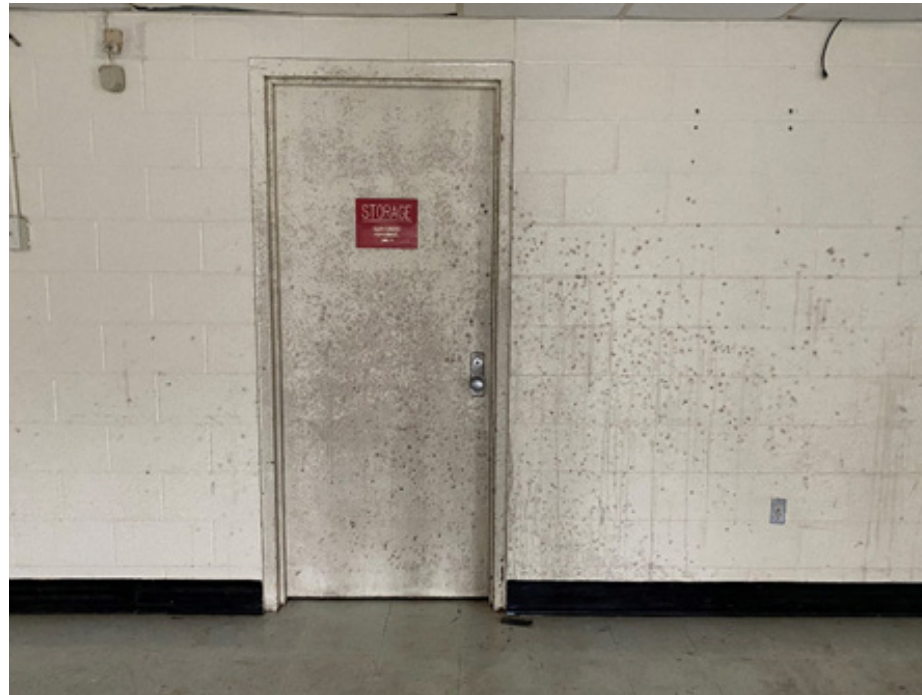
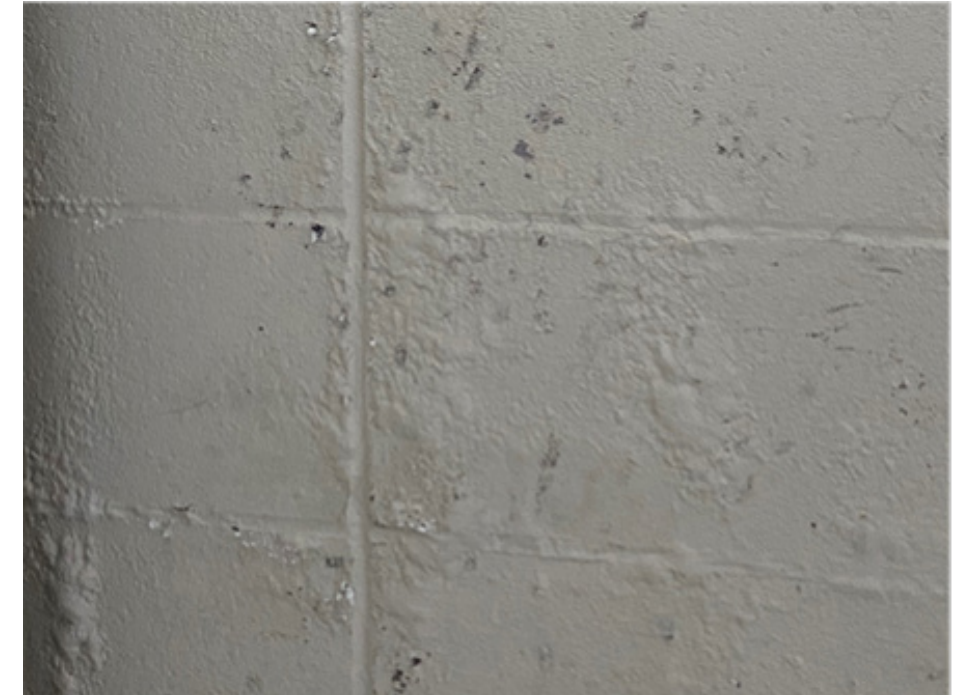
Meeting Room

Front meeting room has small punched window openings on two sides allowing for some natural light to enter the room. ACT ceiling is low and VCT flooring tile is delaminated in multiple locations. Meeting room has some minimal improvements to an audio visual system with a projection screen in the corner. The room is sized to accommodate roughly 100 people at 15 square feet per person, which would accommodate mixed tables and chairs. A more compact setting with rows of chairs at 7 square feet per person would accommodate around 200 occupants.
