Charlestown Civic Center Assessment

November 12, 2020

HWC
ENGINEERING

EOP Architects

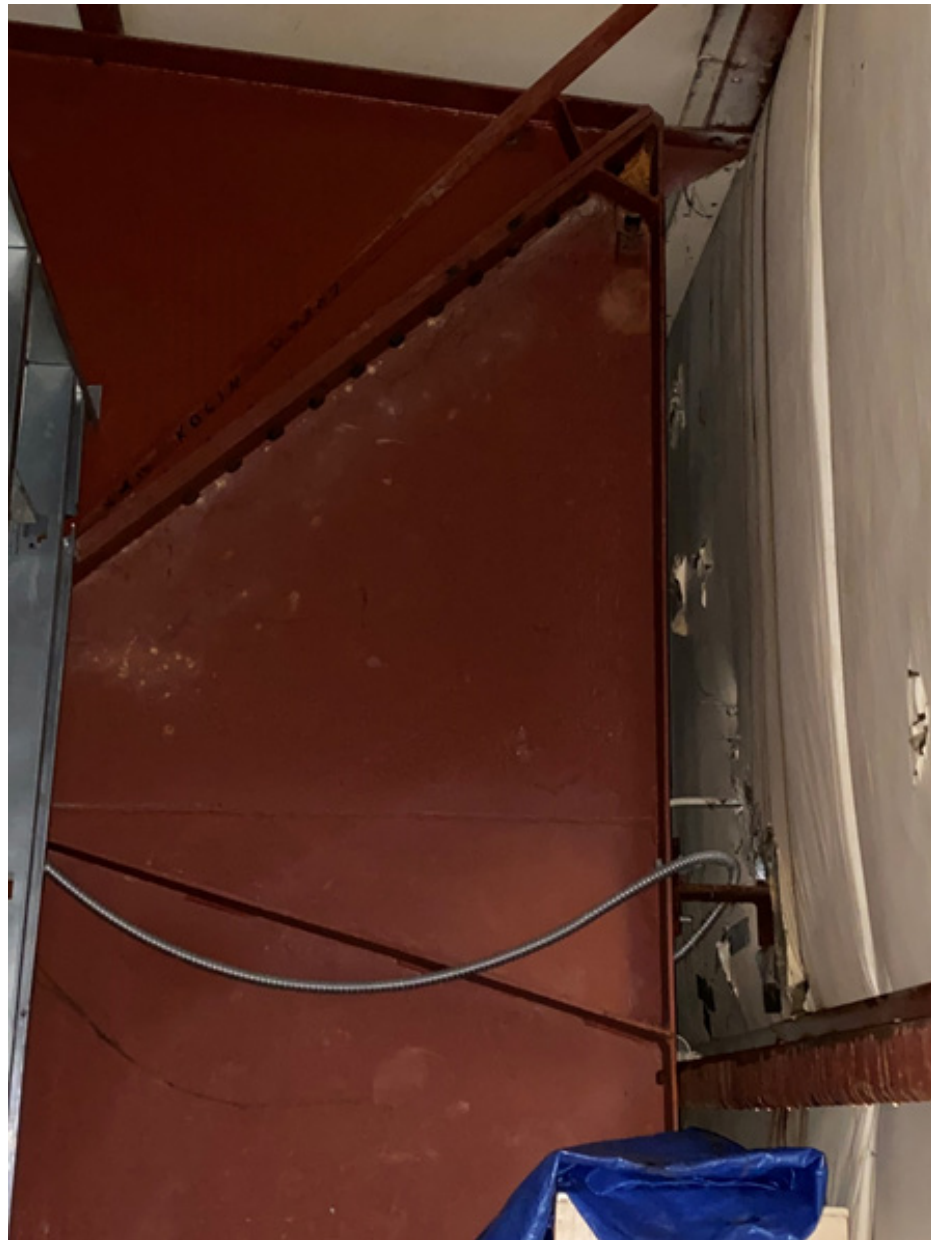
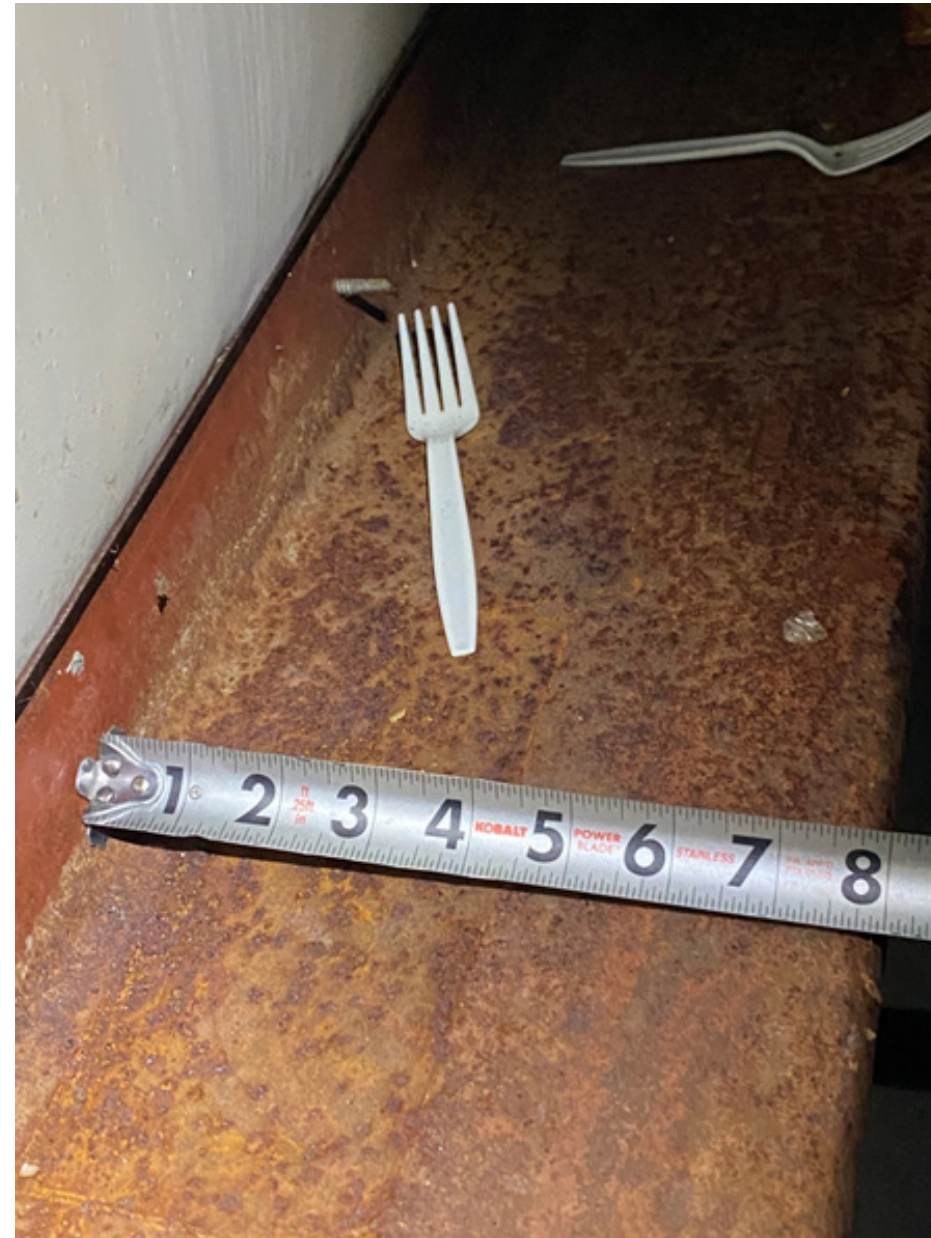
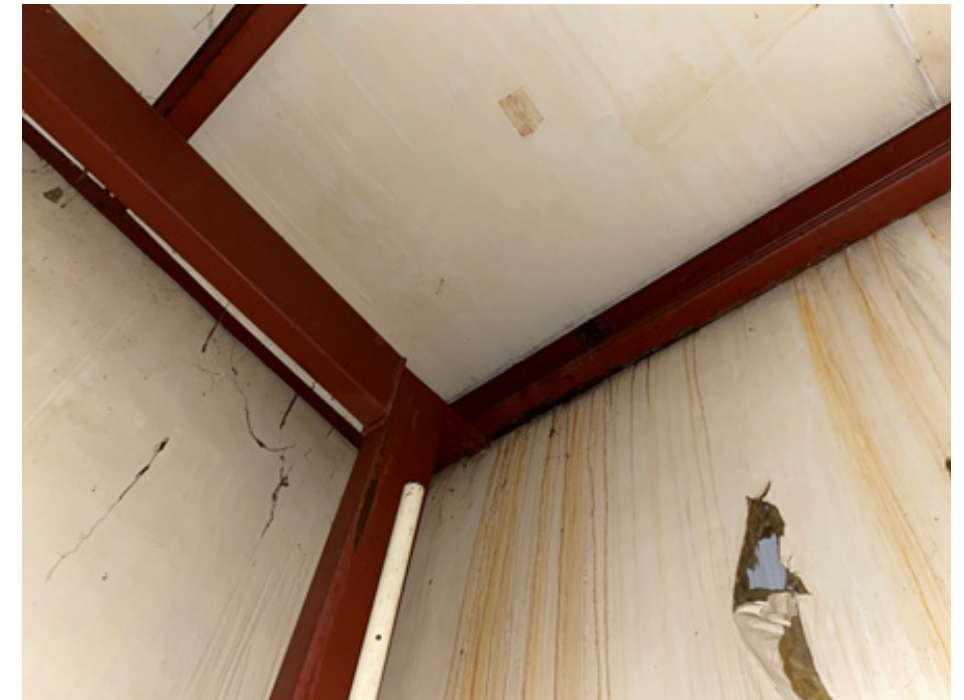
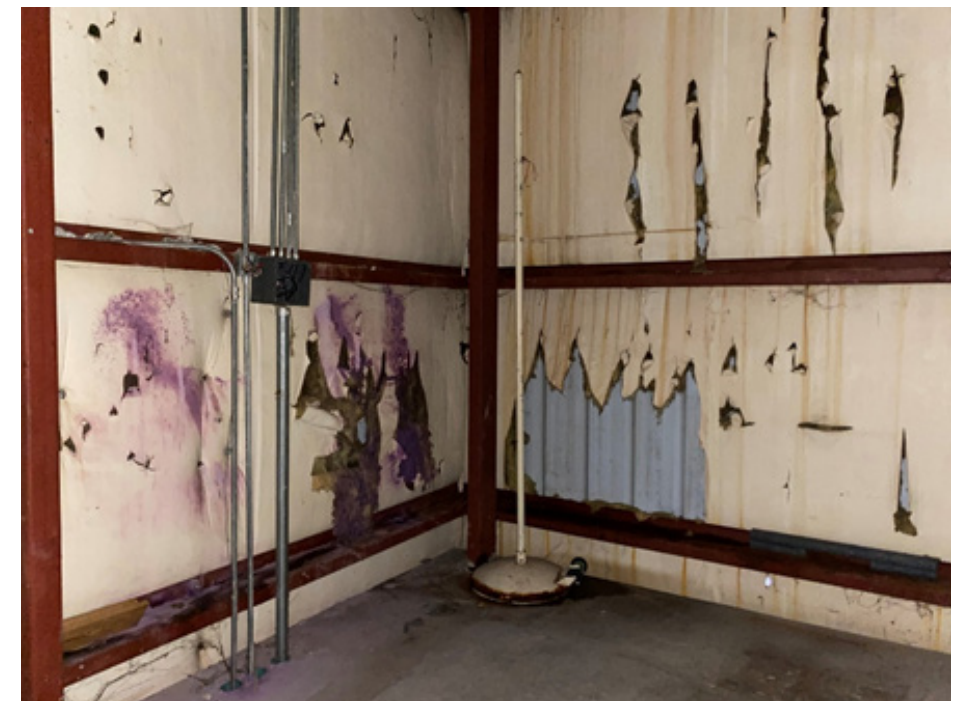
The mezzanine area is approximately 3,000 square feet, overlooks the gymnasium below and was most likely used as a viewing platform. It also appears to have a secondary use as a storage and practice area. Room enclosures were added on each end. One houses cheerleading trophies and may have served as a practice area. The other end was used for storage. Tapered roof structure does become low on one end of the mezzanine. Flooring structure is a concrete deck supported by steel metal joists. VCT flooring largely appeared to be in acceptable condition. Railings are non-code compliant and are a significant safety hazard as one could easily slip through the railings to the floor below. Some active roof leaks were observed, with some structure exhibiting surface rust and pitting. Vinyl scrim covering fiberglass insulation was torn in multiple location along walls.

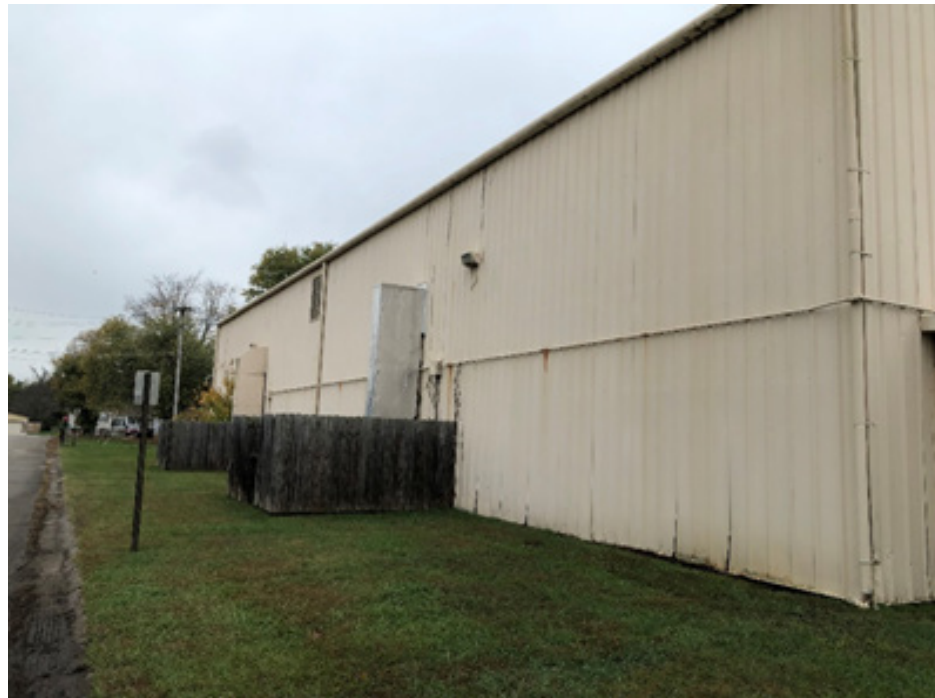
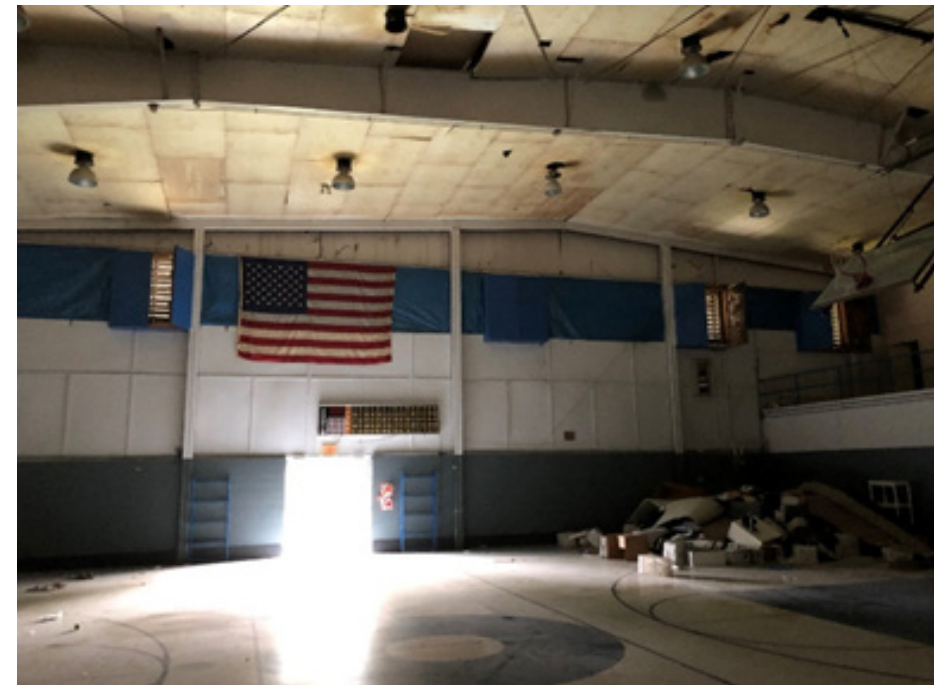
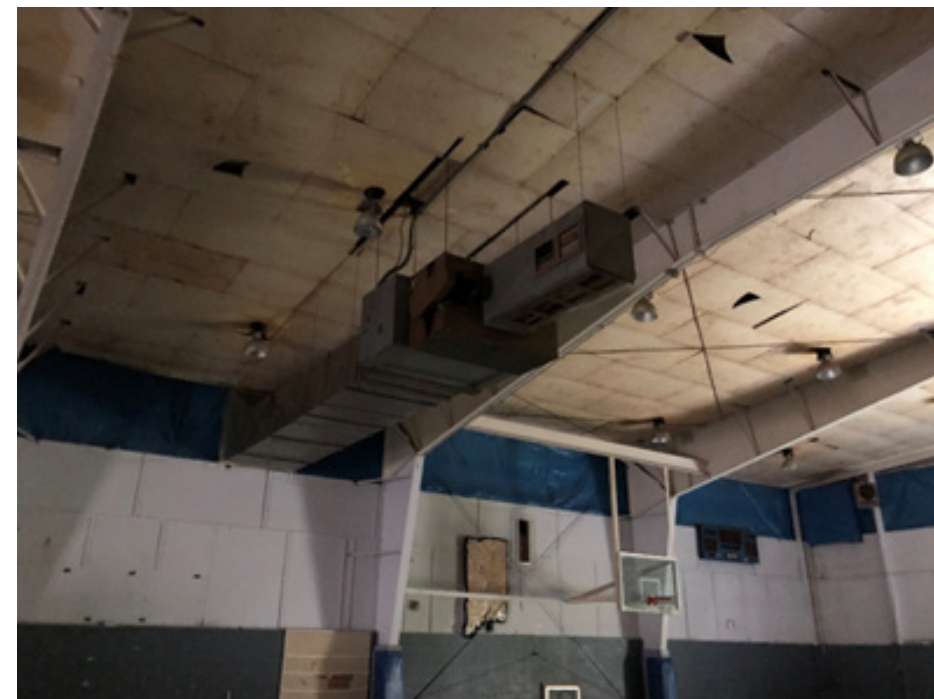
The grade surrounding the building is at or above first floor slab, which results in negative or flat slope and limited positive drainage away from the building. Additionally, the parking lot only slopes slightly away the building causing ponding water and saturated soils around the base of building. Although there are minimal site drainage inlets, minimal evidence of areas of ponding water were visible in the parking lot. The existing asphalt pavement appeared to be in fair condition. Areas of cracking or other deterioration were evident, and some of those areas require repair/replacement.

Water meters are located on the southwest side of building. The gas meter is located on the southeast side of building, adjacent to Steve Hamilton Drive. The existing electrical and telecommunications overhead feeds enter the site from Steve Hamilton Drive and run along the southwest side of the building to a pole with pole mounted transformers near the west corner of the building. Electrical and communications services extend to the building from this pole.

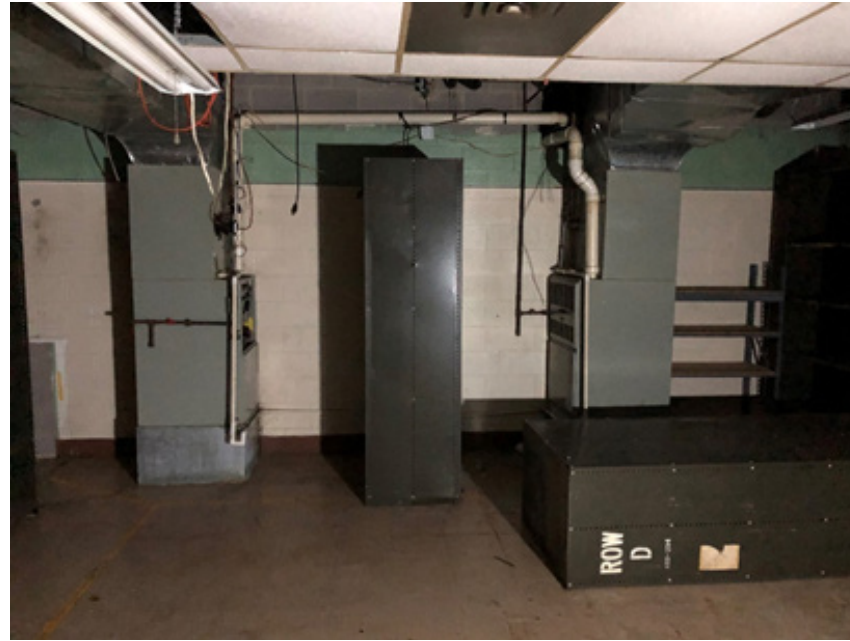
There are two ground mounted air handlers outside of the gym that supply conditioned air across each court. The return is located low on the wall and the supply is located about halfway up the wall. There is exposed ductwork on the outside of the building.

There are offices/restrooms/meeting spaces in the front of the building. These spaces are conditioned by two (2) Trane split systems. The two (2) furnaces are located next to each other indoors and are ground mounted vertical units. The condensing units are located outside towards the entrance of the building.

It is recommended that all existing equipment be demolished completely. The equipment has not been operated for a few years, does not appear to be in working shape, and does not meet current code.

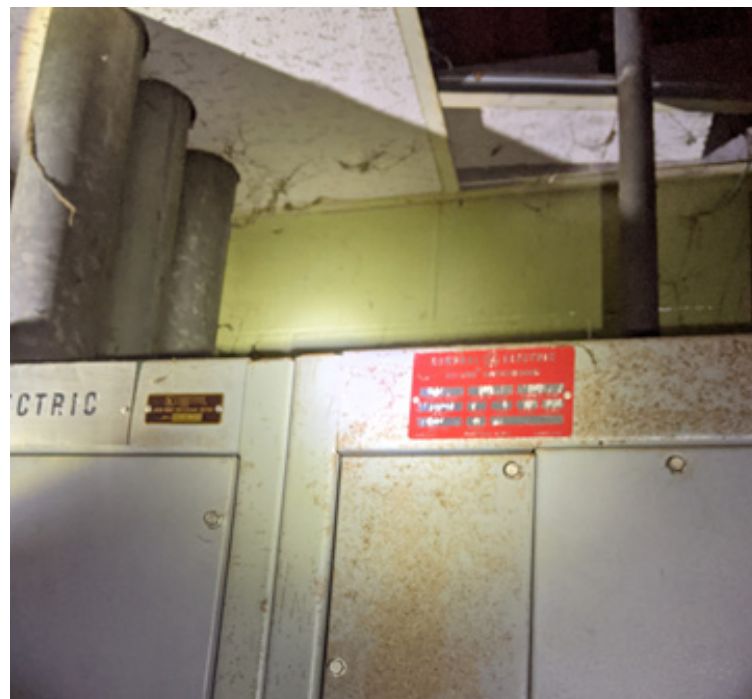
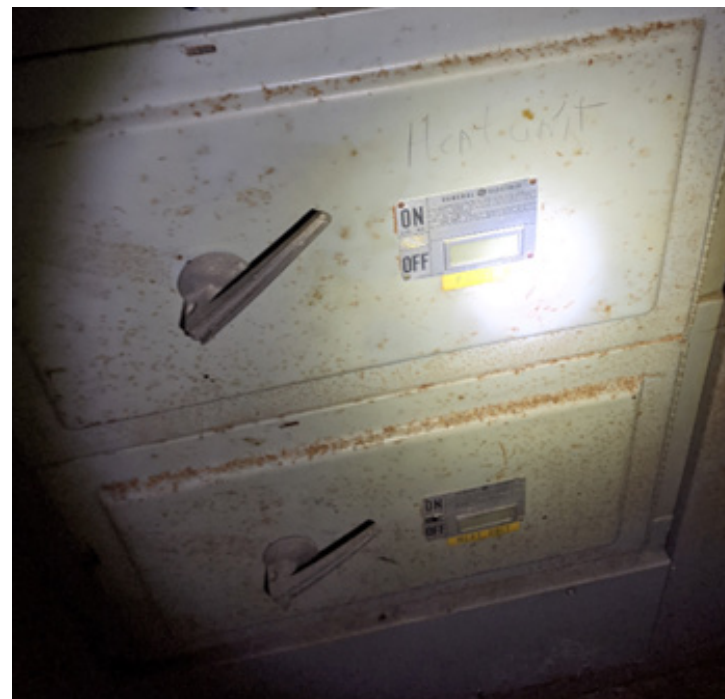
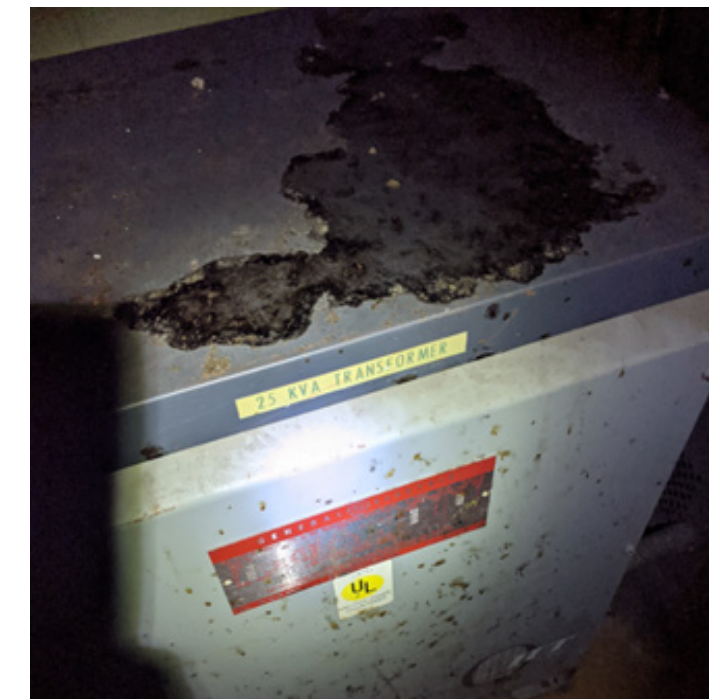
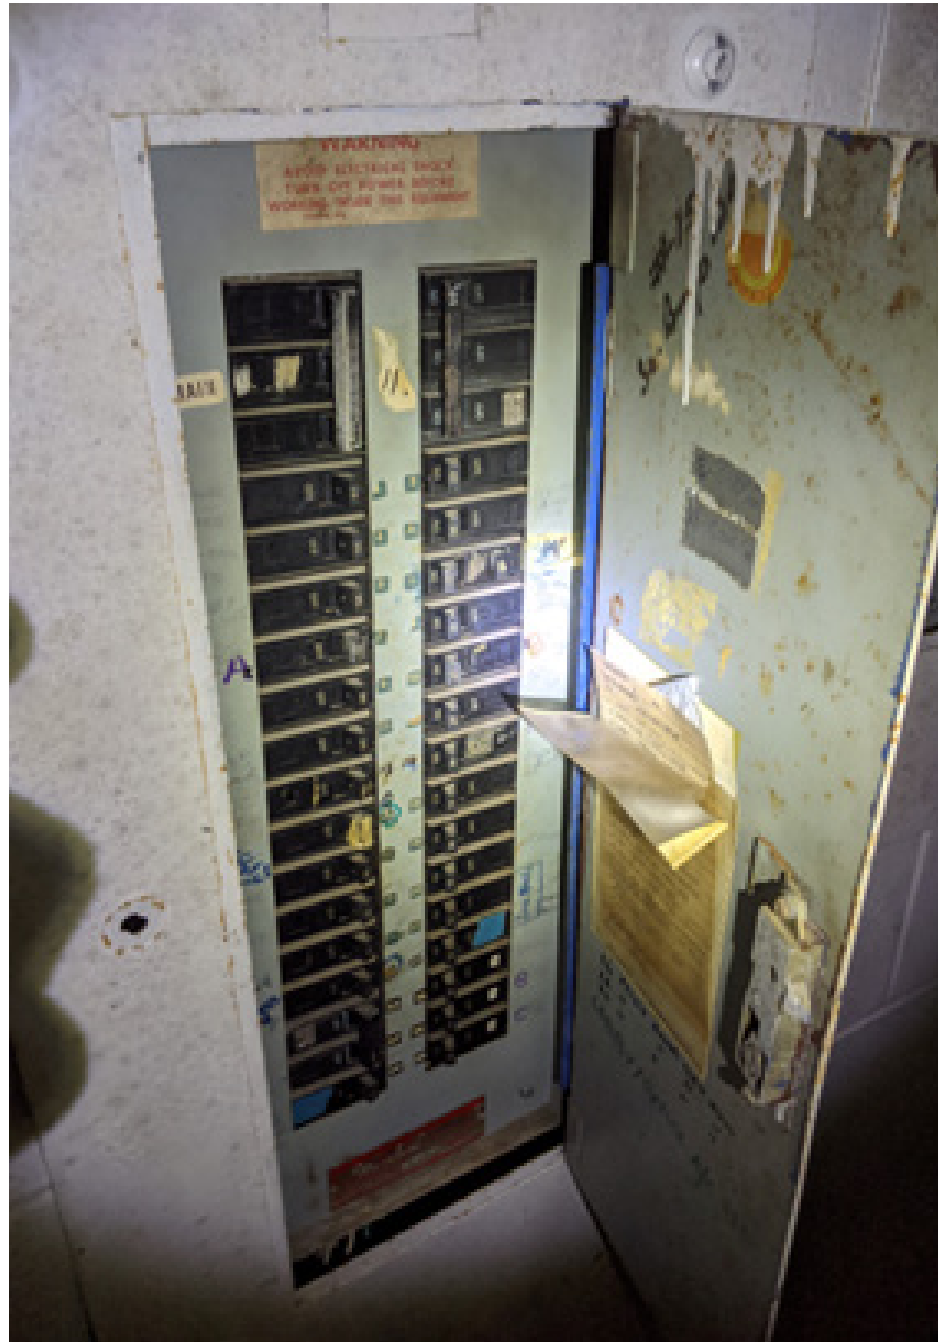
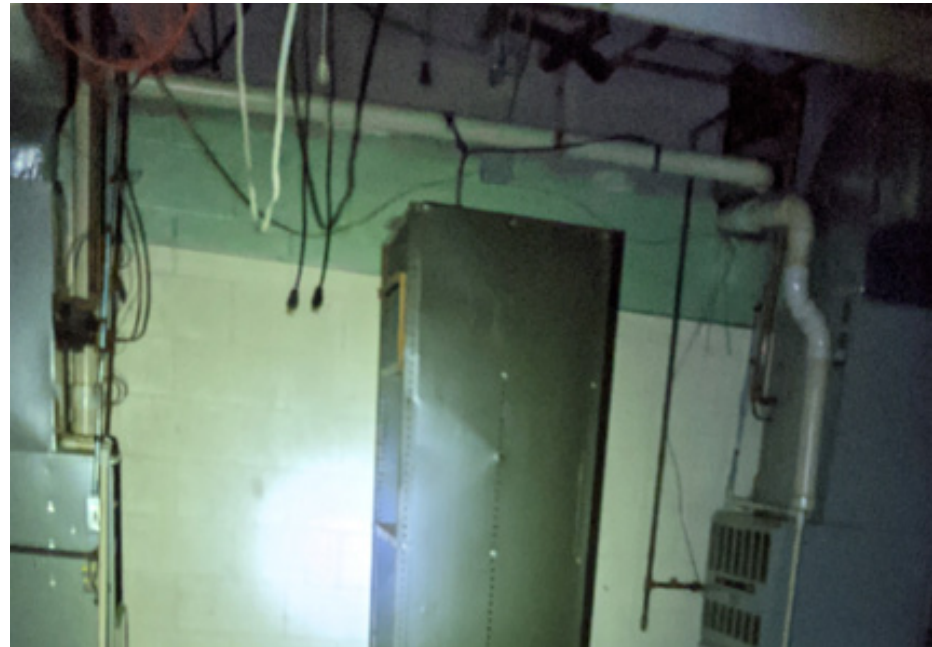
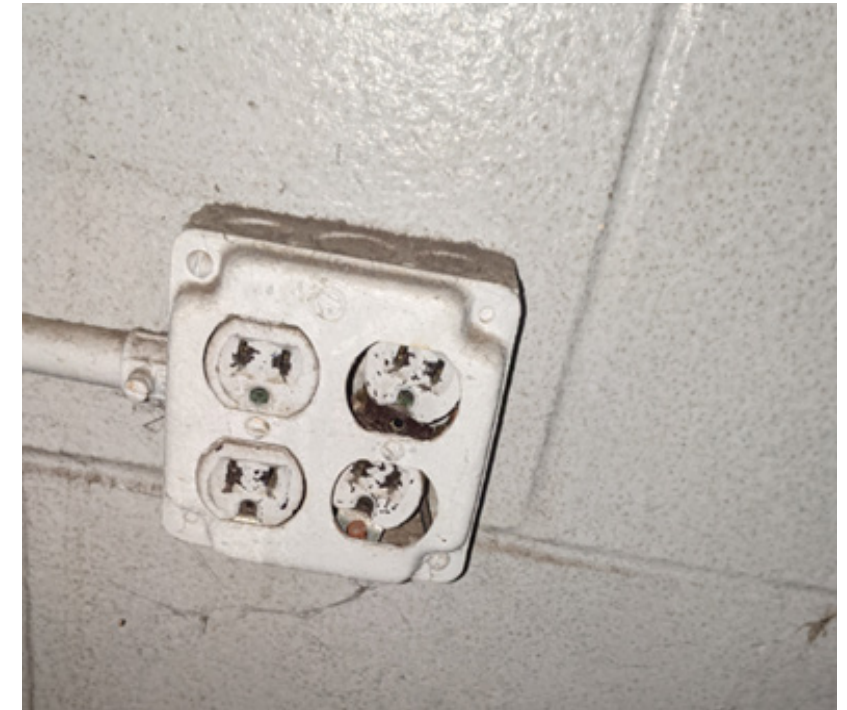
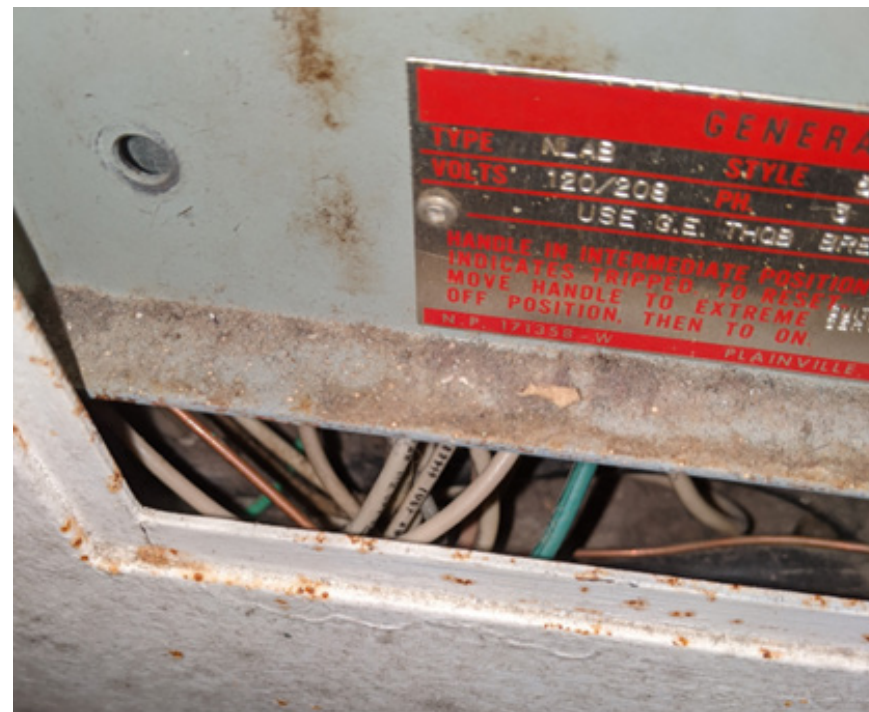
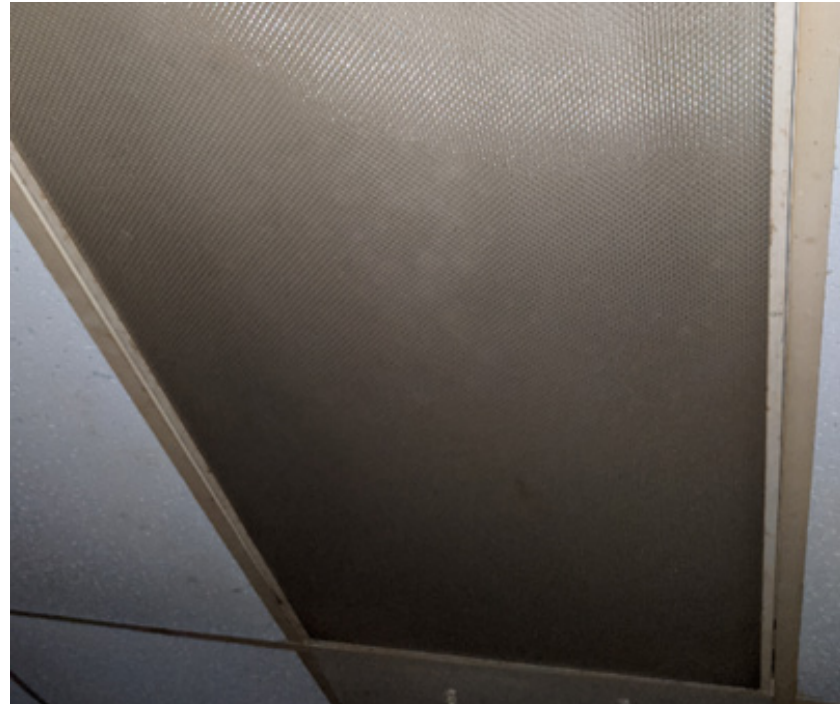
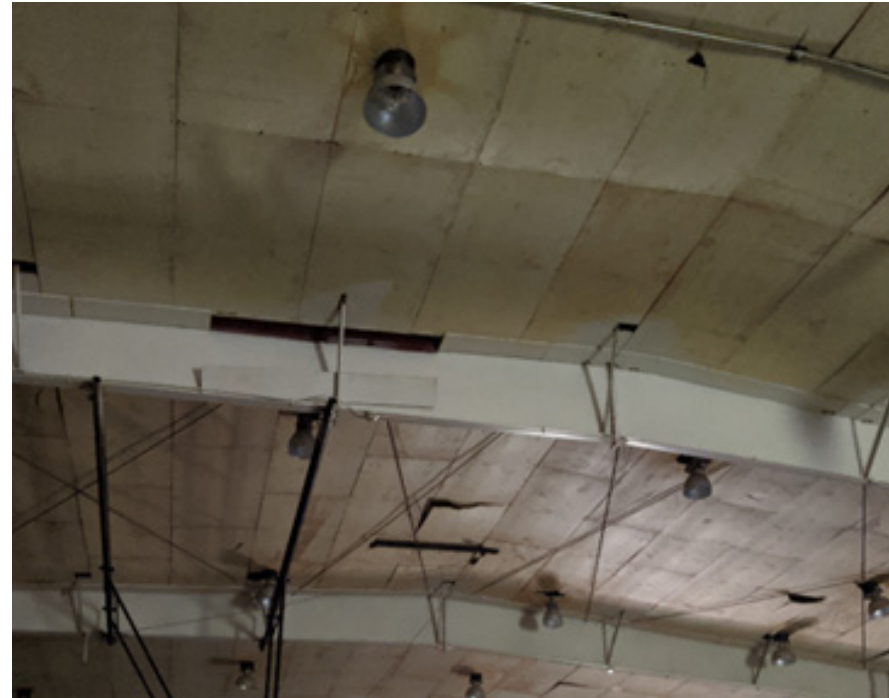
The existing distribution equipment is outdated and damaged. The equipment appears to be original to the building. Water damage and rust were observed as well as standard wear and tear of the equipment. Multiple panels are not properly secured to the walls. The covers of the panels do not conceal the live wiring within the equipment. Due to the age of the equipment, replacement parts are increasing more difficult to find which contributes the difficulty for future maintenance or repairs.

Receptacles throughout the building were observed to be damaged. In addition, bare neutral wires were seen within the panels. Multiple areas throughout the building have wires hanging down from the ceiling or damaged and exposed.

The existing light fixtures in the gymnasium are outdated high-pressure sodium fixtures. These light fixtures are difficult to maintain and consumed large amounts of power compared to today's standard of high efficiency LED light fixtures. The lights appear to have been damaged over years of activities as well as roof damage and leaks.

It was observed that several light fixtures are also not secured to the structure and ceilings. These lights were hanging from above by the wiring instead of the housing of the fixtures.

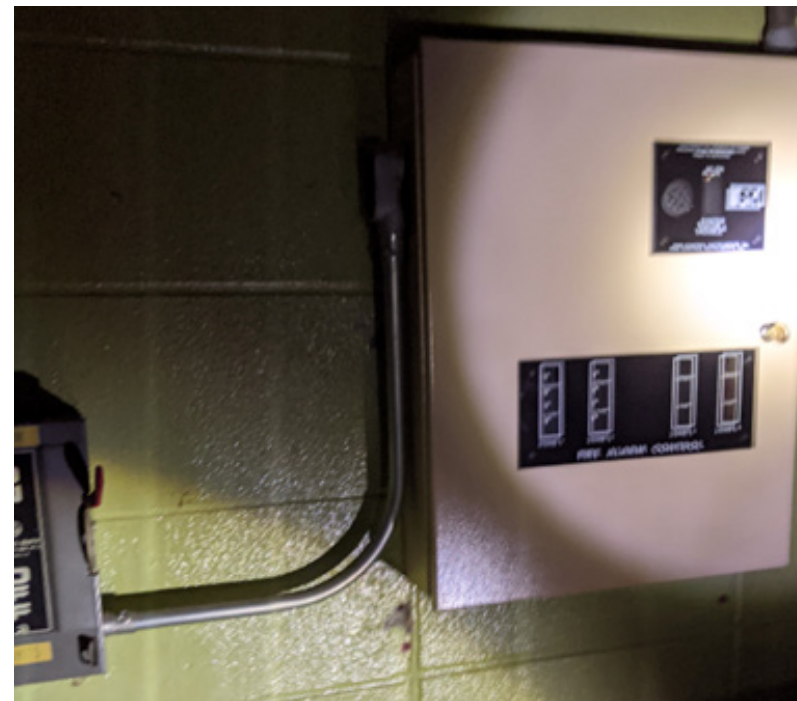
The fire alarm system is an FCI (Honeywell) system. It is outdated and does not comply with modern code. The system does not have voice evacuation capability. Also, the manual pull stations do not adhere to ADA standards.

The building lacks full smoke or heat detection coverage for automatic initiation of the fire alarm system in the event of a fire. Also, the building does not have full notification coverage with audio and/or visual means.

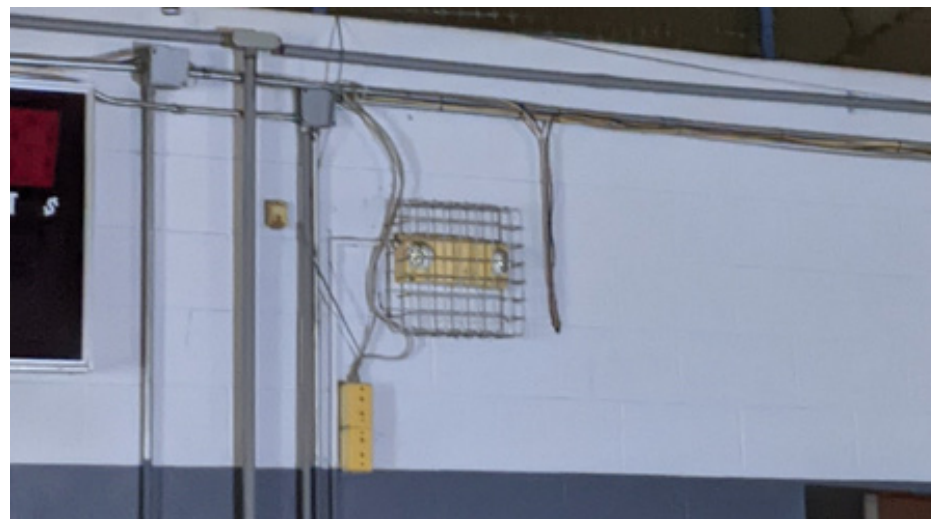
The Information Technology and Data network for this building appears to be a copper/analog system with outdated horizontal and riser distribution cabling.

The existing intrusion detection system is damaged. It was observed that motion detectors there knocked off of the walls.

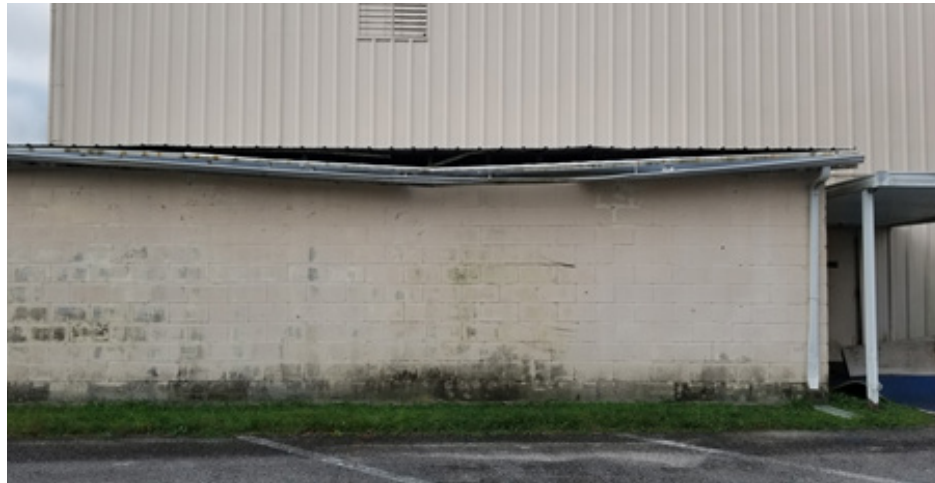
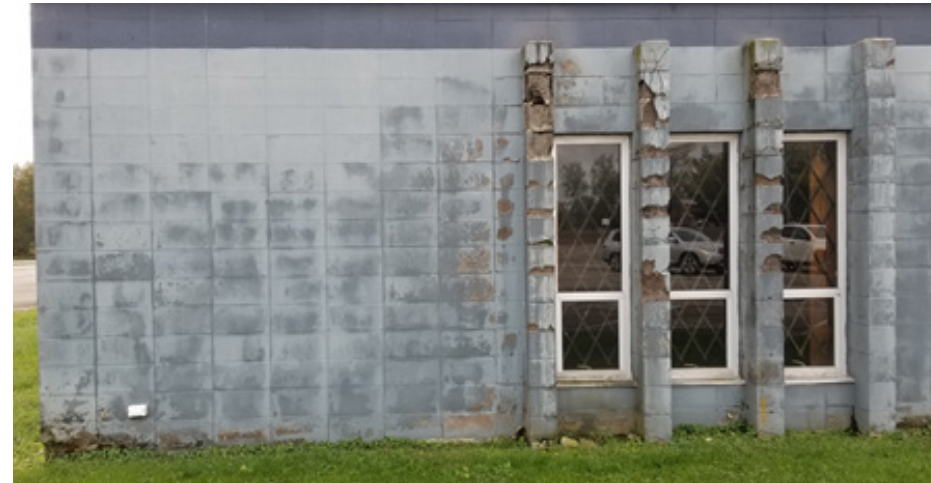
The non-load bearing CMU walls around the exterior of the building are highly deteriorated. Crumbling CMU block and cracking was observed in multiple locations. Water was observed ponding against the foundation due to missing/damaged downspouts.

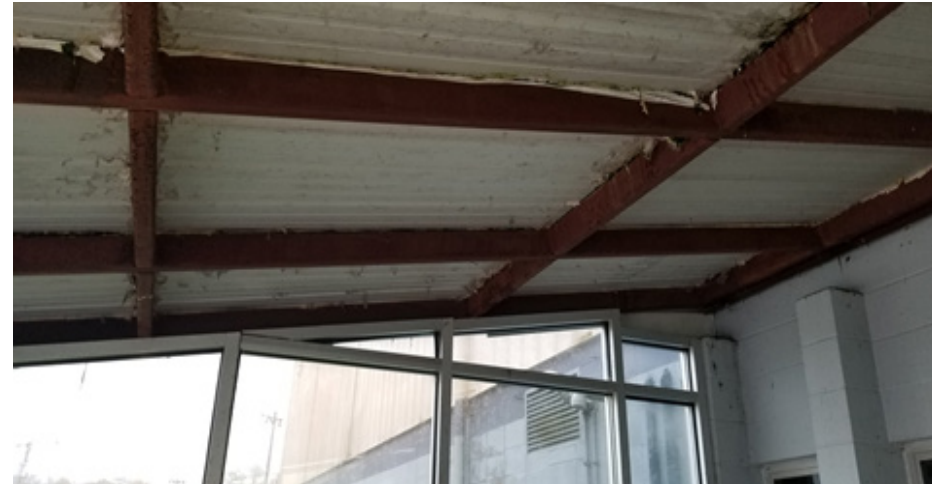
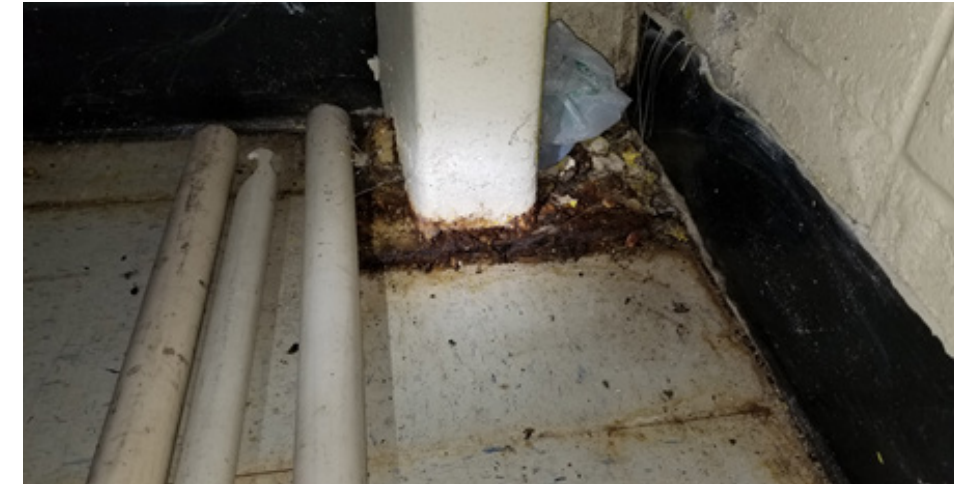
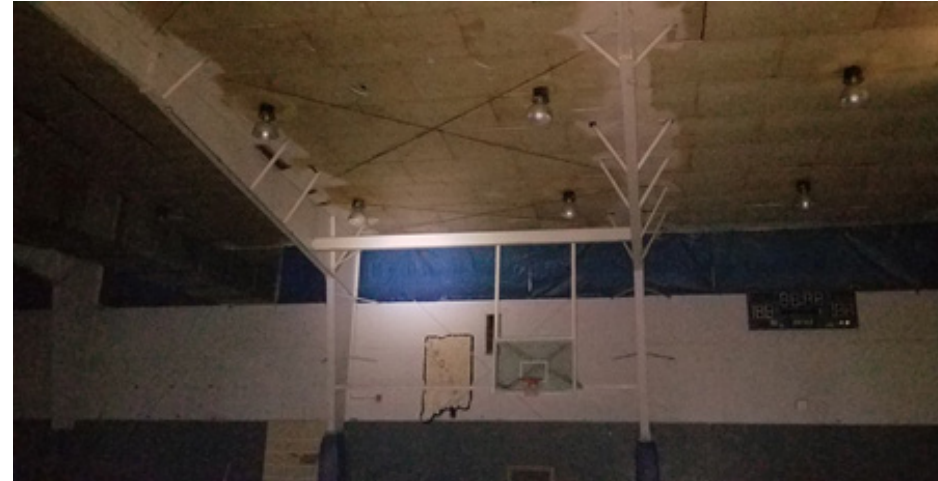
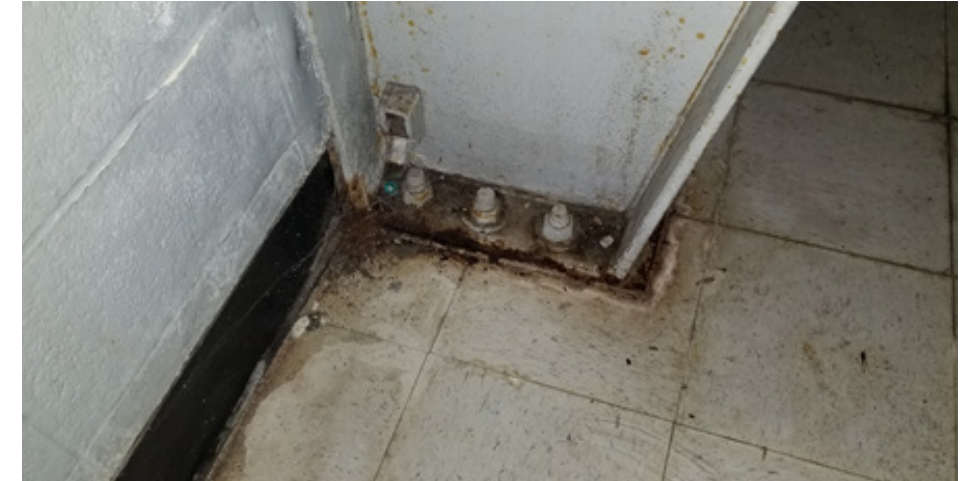
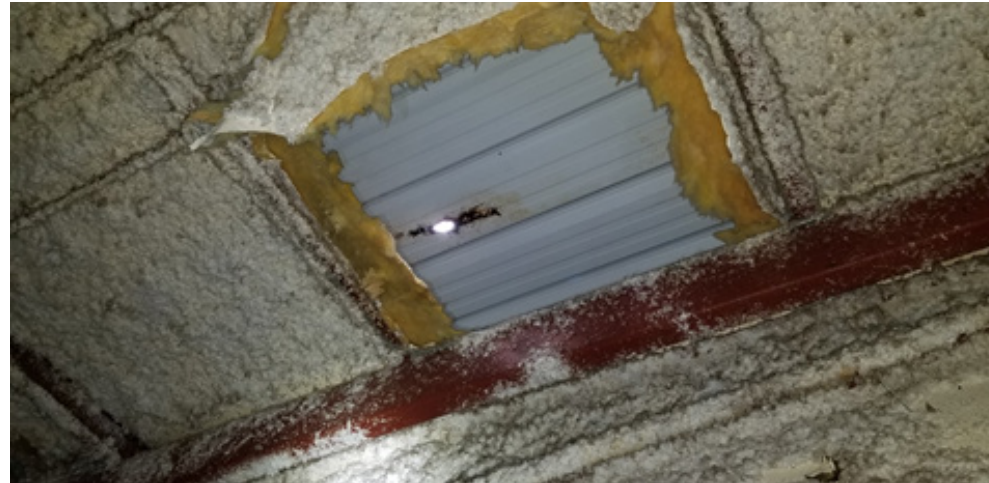
The roof of the building appears to be leaking in multiple areas. Most of the roof deck is covered with interior panels or insulation and was not visible. The areas of the roof deck that were uncovered and observed were in deteriorated condition. The overall condition of the roof deck is poor and complete replacement should be considered.

The roof in the Northwest corner of the building, above the mezzanine, is leaking and has allowed the columns and girts to accumulate surface rust. This rust does not appear to be detrimental to the structure. The interior CMU bearing walls below the mezzanine are in above average condition. The renovation plans will likely involve demolishing the mezzanine to allow more floor space.
